Treatment of old disused mine openings

TREATMENT OF OLD DISUSED MINE OPENINGS

C. DIDIER^{*}, F. WOJTKOWIAK^{*}, R. SALMON^{**}, J.P. BARRIERE^{***}, P. GAGET^{***}.

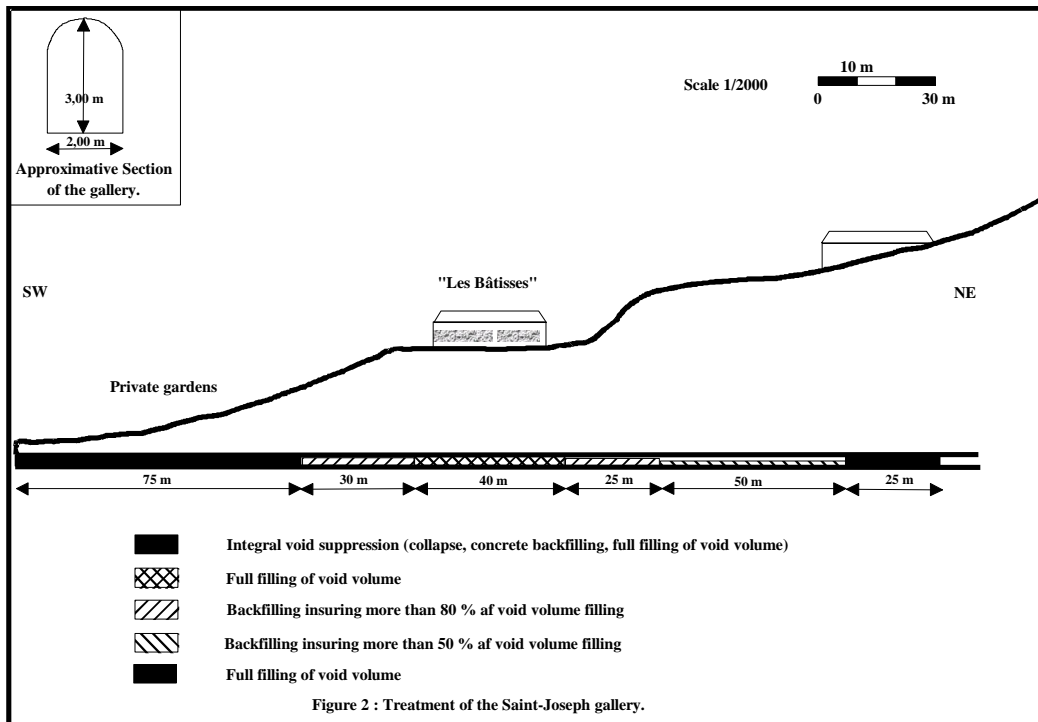
- in the gardens located close to buildings called « Les Bâtisses », one can notice the presence of sandstone with soil. Because of dense vegetation making any visual observation very difficult, it has been assumed that the opening of the gallery was situated within this formation ;
- « Les Bâtisses » were founded on fill made of mining materials. If we assume the height of the fillslope being approximately equal to the thickness of the in-situ layer, it is around 5 m thick (fig 2).
