## Case studies and analysis of mine shafts incidents in Europe

Amélie Lecomte, Romuald Salmon, W. Yang, Alec Marshall, M. Purvis, S. Prusek, Slawomir Bock, L. Gajda, J. Dziura, Agustin Munos Niharra

### **Abstract**

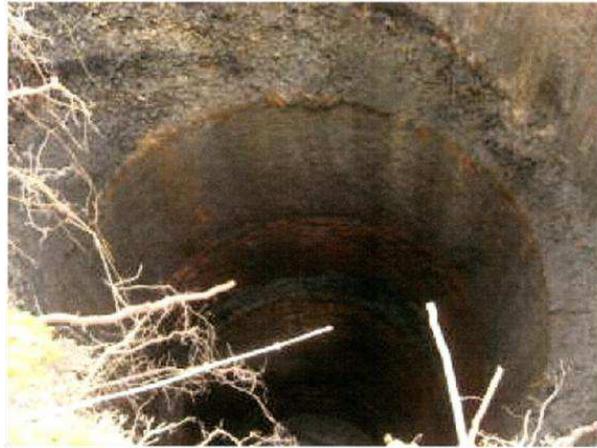
The case of Lancashire n°6 upcast shaft, in England, also illustrates this kind of incident. This 4.1 m diameter circular shaft, around 200 m deep, was filled in 1927 with soft material. In January 2007, a void about 4 m diameter at 20 m depth was observed from ground level. Brick lining remained suggesting a collapse of filling material that did not lead to the rupture of shaft head (Figure 1).

*Figure 1 : Collapses of Lancashire No.6 Upcast Shaft  
(Source: UK Coal Authority).*

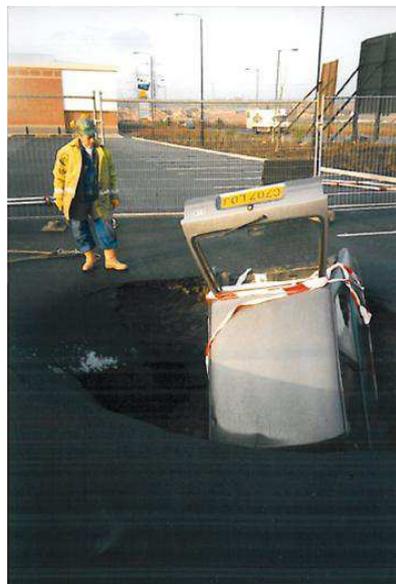
The case of West Midlands Shaft, in England, illustrates this kind of situation. This 3 m diameter circular shaft, 144 m deep, suffered a collapse of ground approximately 3 m diameter and 2.5 m deep in a car park area in 2000. Collapse became apparent when surfacing failed over a void due to weight of a car (Figure 2). Two occupants in the car escaped with only minor injuries.

*Figure 2 : Collapse of ground in the car park area  
(Source: UK Coal Authority)*

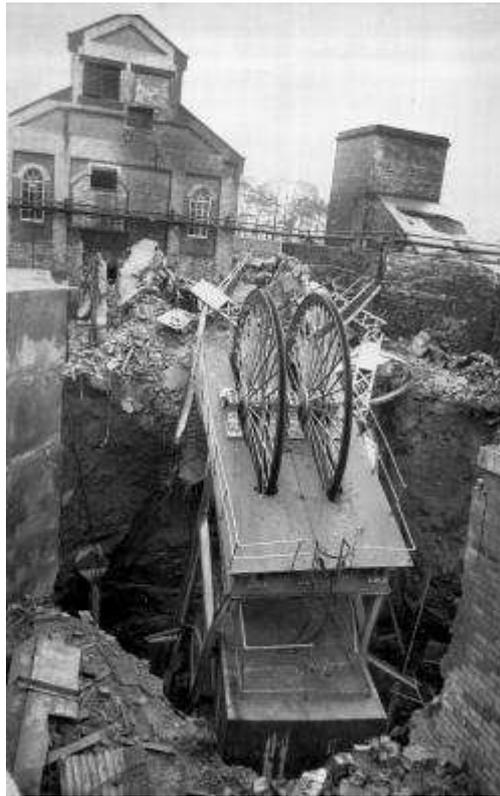
- Coal shaft V, Knurów-Szczygłowice colliery, in Poland. A detailed analysis is presented in Section 3.
- Shaft n°1 and n°2 at Barony Colliery Ayrshire Scotland (England): sunk between 1906 and 1912, shaft n°1 and n°2 are rectangular (resp. [6.4 m x 3.3 m] and [4.9 m x 3.3 m]), wood lined and 633 m deep. In 1960/62, modification of ventilation systems took place. N°1 shaft was originally used as the Downcast / coal winding until 1962. Following completion of works at the shaft head, it was re-commissioned as an upcast. N°2 shaft was an Upcast. After conversion of ventilation system, shaft n°2 collapsed following deterioration of wood lining (Figure 3), that may have been caused by contact with upcast air of high humidity.

Figure 3 : N°2 Shaft following Collapse (Source: MRSL)

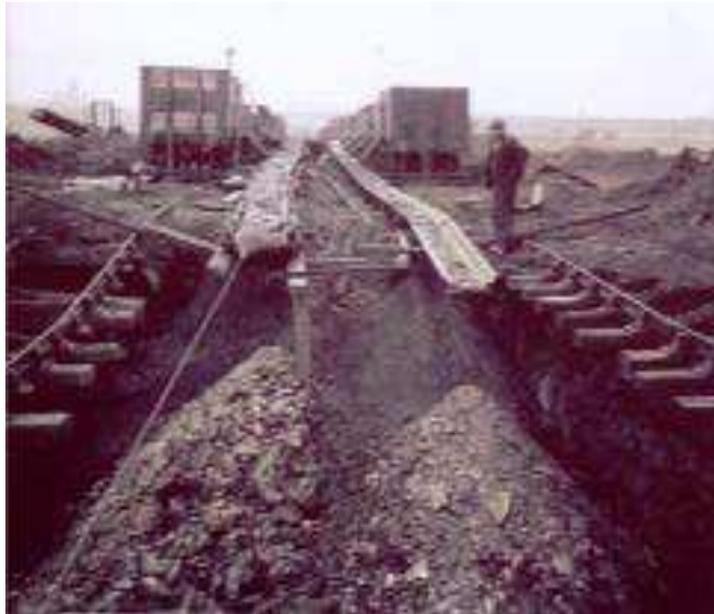
- West Midlands shaft (England), introduced previously.
- Low Hall n°7 (New Zealand Pit) at Abrams Lancashire, in England. The shaft is circular (3.66 m) and 305 deep and was sunk circa 1885. All mining via the shaft was abandoned in 1919 (1924?) although the shaft was retained for ventilation until 1932 (1931?) when it was filled with a reported 8,120T of debris. In April 1945, some 13 years after the mine shaft had been filled the locomotive was shunting a train of 13 loaded coal wagons (full length 86m) when the ground beneath the line cratered and collapsed (Figure 4). The last wagon entered the crater pulling the rest of the train and eventually the locomotive with it. A few days later, when the dust cleared, the front of the locomotive could be made out 30m below pointing upwards.

*Figure 4 : Infilling Shaft Post Collapse (Source: MRSL)*

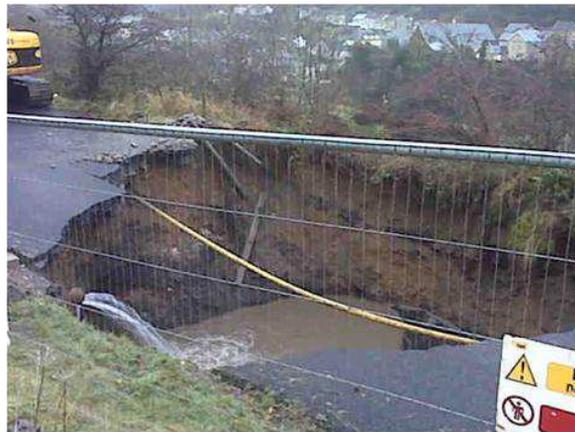
Shaft located at Tirphil, New Tredegar (England): this circular, 10 m diameter, shaft was last recorded in 1965. The collapse of shaft was reported at in November 2010. It was described as a hole in the road, 4 m deep, 4-5 m diameter, brickwork was visible and water was entering the hole from a culvert. The collapse was near the railway line and road between Brithdir and Tirphil. Due to water ingress from the culvert, the collapse grew in size and the following morning was approximately 10 metres diameter, 15 metres deep and filled with water to approximately 4 metres from road level (Figure 5). Whilst the cause of the collapse is unknown the location corresponds with a recorded mine shaft.

According to the desk investigation of Coal Authority data, it was found that the collapse is on the position of a mine entry. Shallow recorded mining exists beneath the site at approx 22m below road level and deep mining between 370 m and 480 m. The Shaft is connected to an adit. The adit is detailed as “the lowest free drainage for the Brithdir Seam in the Rhymney Valley” on abandonment plan 6467. The workings within the Brithdir Seam dip at 1in15 to the SSW. The roadway between the shaft and adit ran on the strike of the seam and the adit was c.20m below the surface level of the shaft.

*Figure 5: the collapsed shaft at road between Brithdir and Tirphil  
(Source: UK Coal Authority)*

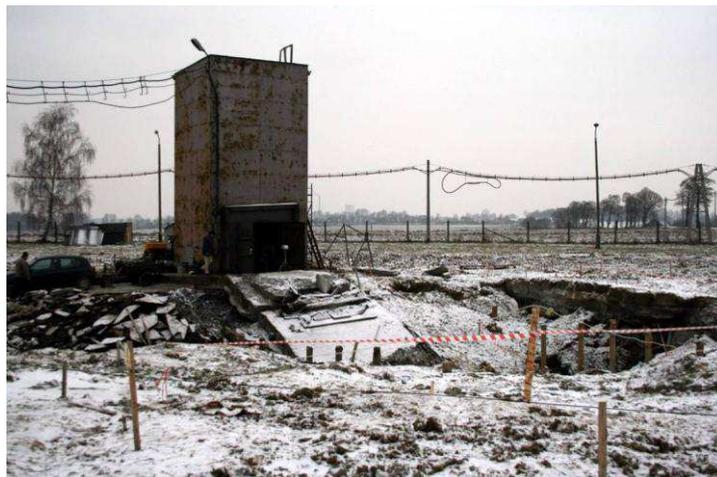
On 5 December 2007 at 12.15 o'clock during an inspection a ground surface deformation was observed between shaft V and a ventilation shaft over a length of 8.0 m. At the beginning, two 1 - 1,5-m deep craters were observed on the south-eastern and north-western side of shaft V, which already on 7 December 2007 had a diameter of circa 5,0 - 7,0 m each. The craters were located on both the sides of ventilation drift at a not large distance to shaft “V”. Not later than the first days after the aforementioned event the craters united into one that continuously grew.

What caused the catastrophe was the inrush of a quicksand strata into the shaft. The strata found a way into the shaft in a leak of the shaft lining at the connection of the ventilation drift to the shaft. This caused loosening of ground under the drift and its vertical displacement by about 2,0 m (Figure 6).

*Figure 6 : The crater in the neighborhood of shaft “V” (Source: GIG / KWSA)*

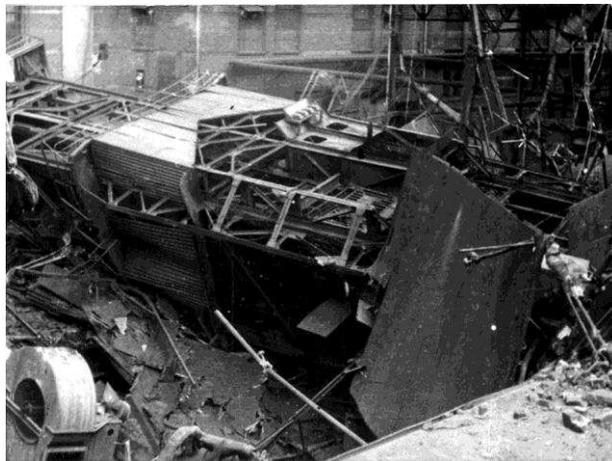
The catastrophe of shaft Bolesław took place on 6 September 1975. On the western side of the shaft a crater came into being that uncovered foundations of the shaft bank house. After several hours the increasing crater caused a collapse of the shaft bank building which leaned against the headframe’s angle struts breaking them and causing a collapse of the headframe (Figure

7). The event was characterised by a very dynamic course and lasted merely 15 hours.

The primary cause of the accident was a quicksand inrush into the shaft at a depth of 24 m. An increased outflow was observed during the nightly shaft inspection before the catastrophe and a vertical fracture of the lining was located below the outflow point. As a result of falling out of an concrete gutter element a 0,8-m long and 0,2-m wide vertical fissure came into being throughout the whole thickness of the shaft lining. Although a provisional packing had been placed in the gap in lining, made of ventilation fabric and planks, a considerable and violent increase of the gap in the lining was observed after a short time since it began, along with an intensive outflow of sand and water. As a result of water influence and changes in load exerted on the shaft lining the latter began breaking along a considerable length. The quicksand inrush caused that it was necessary to fill the shaft at a depth of from 6,0 m to 160,0 m.

Figure 7 : View of the collapsed headframe (Source: GIG / KWSA)

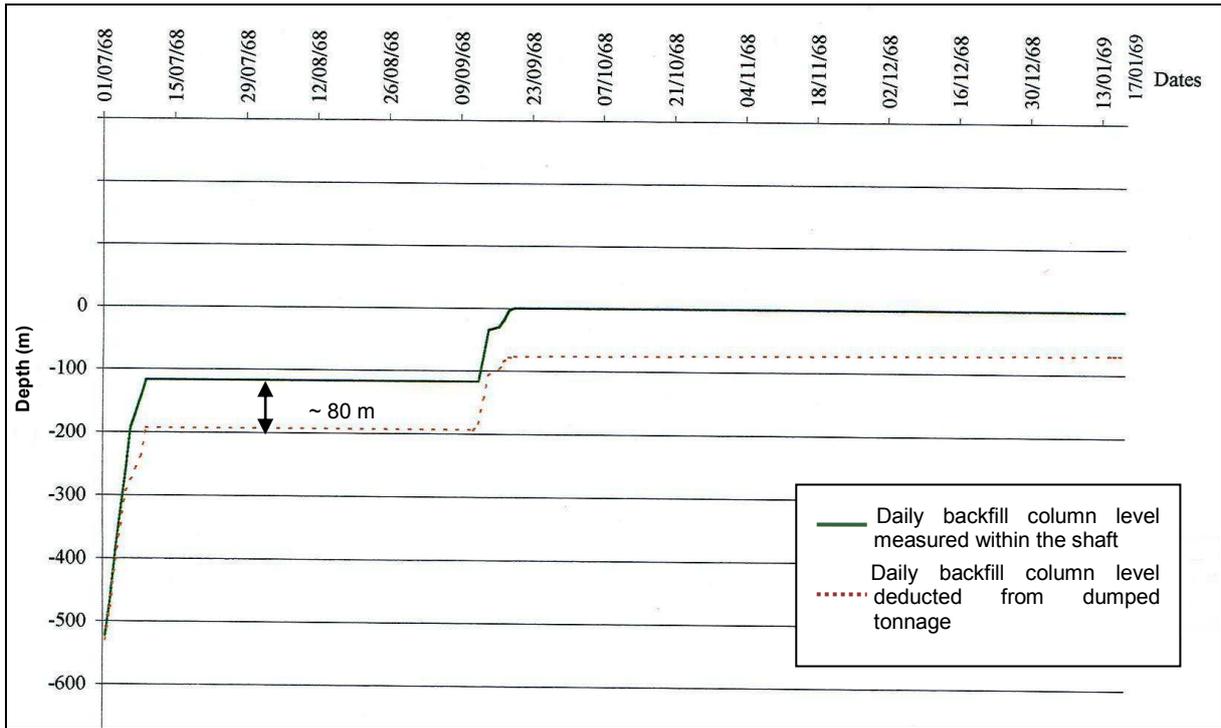
The historic curves deduced from the follow-up of backfill data show sharply the appearance of void formed from the first works of stowing. Figure 9 and Figure 10 show a sensitive and constant distance between the level of backfill material measured in the column of shafts and the level equivalent to the volume of the dumped backfill material. The first one is upper than the second indicating the presence of one or several voids in the column of shafts. Let us note that shafts were not deinstalled before the stowing and the presence of metallic structures within the column of shafts can ease the creation of backfill material vaults.

Figure 9 : backfill level evolution – Shaft n°8 – from 01/07/68 till 17/01/69

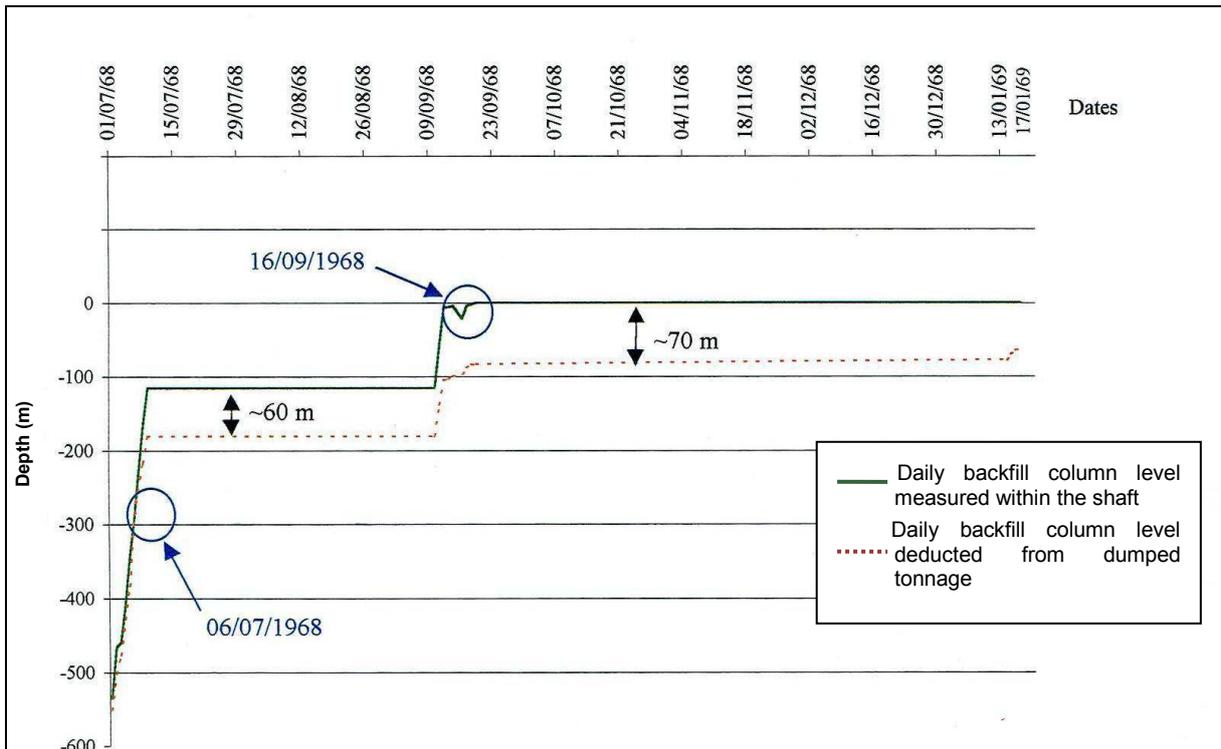
Figure 10 : Backfill level evolution – Shaft n°8 bis – from 01/07/68 till 17/01/69

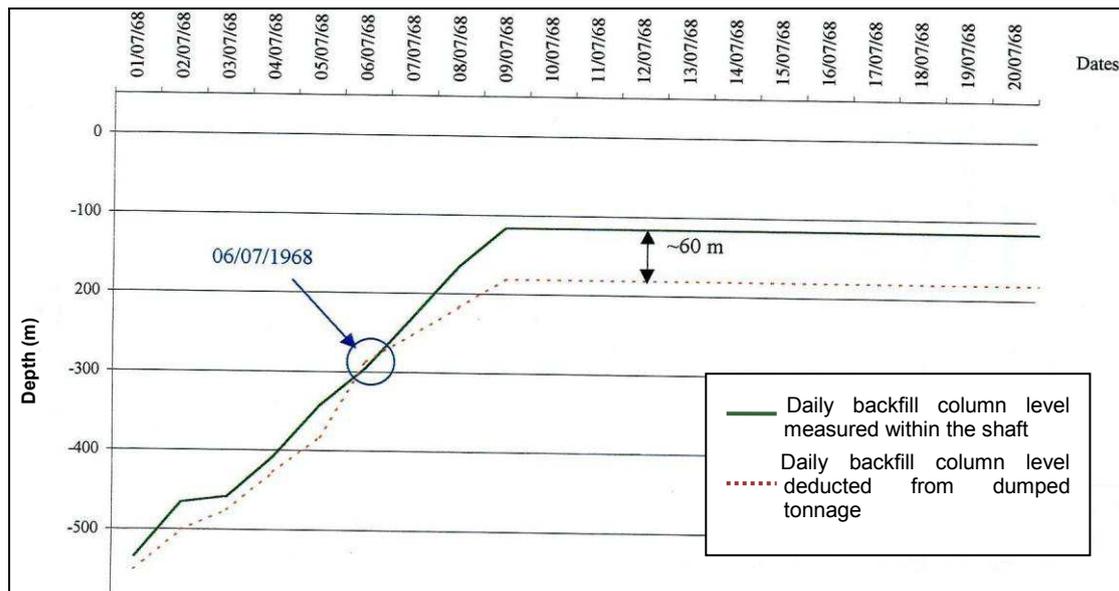
Figure 11 : level evolution – Shaft n°8 bis – from 01/07/68 till 20/07/68

Figure 11 shows the detailed history of the first days of shaft n°8 bis backfilling. It shows that on July 6th, 1968 the measured level is lower than the equivalent level of stowing. 2,035 t of backfill material were dumped. They should have filled an equivalent weight of 92 m but the measure showed that only 48 m of the shaft column were filled actually. The phenomenon of settlement of backfill material in the bottom of shaft column under the weight of superior backfill material does not explain the observed difference:

- the adjustment of the level of the backfill material by filling of the void created previously;
- the failure of the system of closure of one or several stations the departure of backfill material in one or several corresponding galleries.

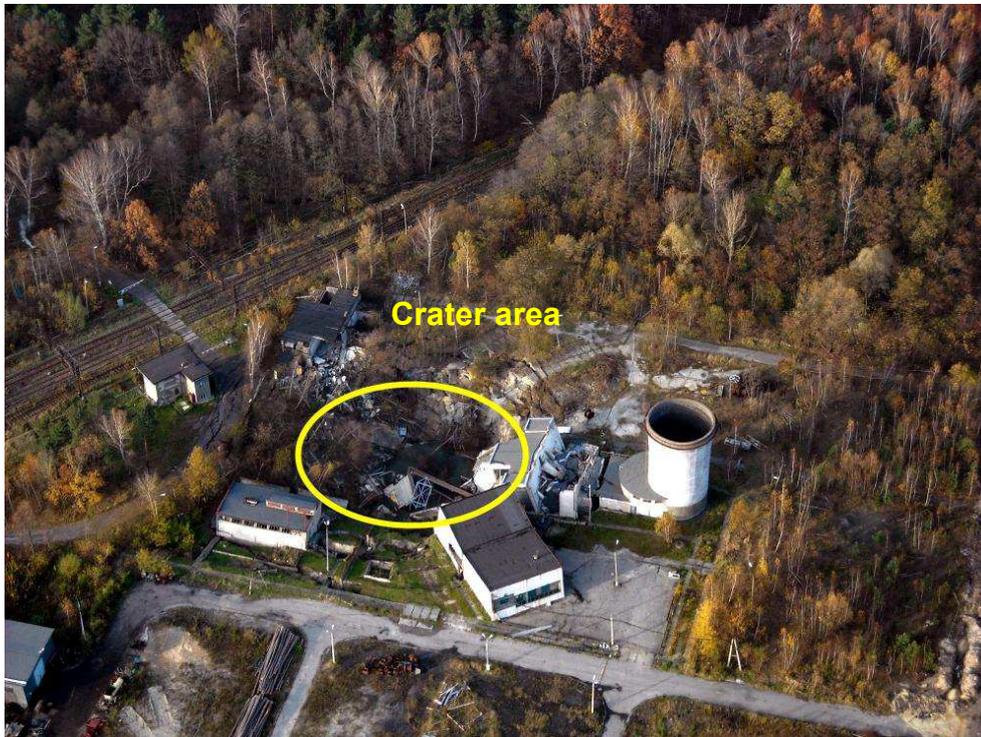
On 4 September 2008 at 4.35 o'clock a catastrophe took place which resulted in shaft lining damage up to a depth of circa 70 m, and afterwards the shaft was spontaneously filled with overburden soil material. This caused that a large crater came into being at the surface that in turn caused damage of building facilities present in its impact zone.

Figure 13 : General view of the scene of the catastrophe of shaft V from the south  
(Source: GIG / KWSA)

The crater had a diameter at the ground surface about 60 m, a depth of around 11 m and an estimated volume of about 30,000 m<sup>3</sup>. Horizontal range of fracture zone at the ground surface affirmed on 4 September 2008 amounted to 67 m.

The primary cause of the accident at the shaft was damage to its lining at a depth of 61 m – 67 m. The damage was a consequence of:

1. Irregular mining repeatedly performed in the neighborhood of the safety pillar of the shaft which influenced hydrogeological conditions which in turn destroyed building-engineering stability of the ground-lining system.

## 2. Poor technical condition of the lining of shaft V.

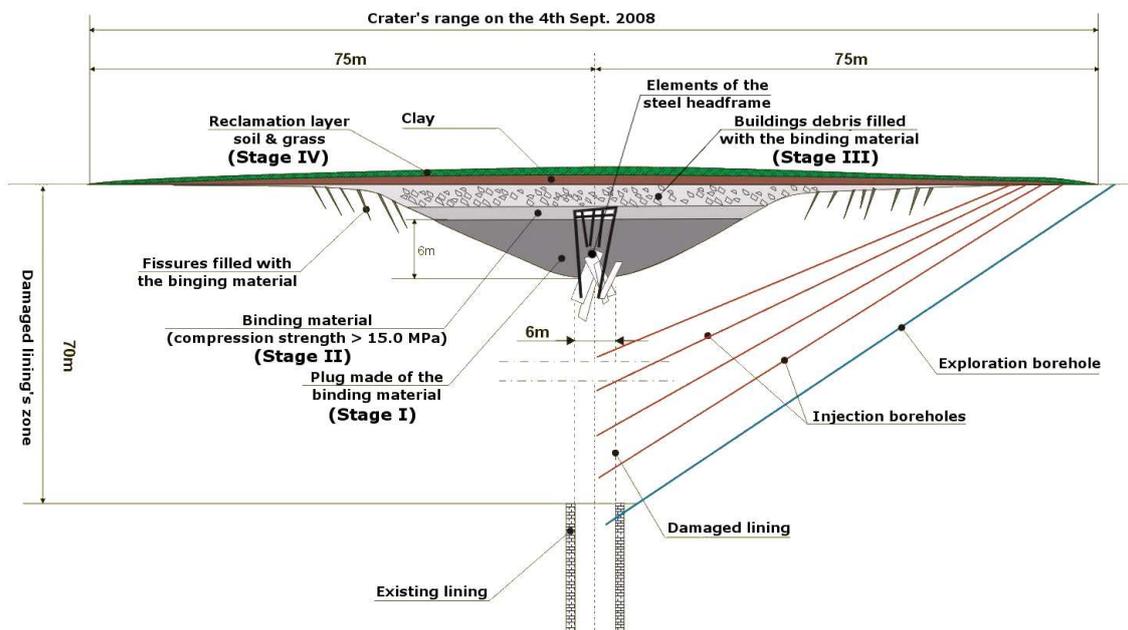
*Figure 14 : Schematic illustration of the crater resulting from the catastrophe of shaft V and its fill*

Empty spaces in the shaft section where the lining damage took place up to the crater bottom were filled with a binder characterised by compression strength of not less than 15 MPa. The spaces were filled after building stoppings at levels 450 m and 350 m. The filling material was supplied through holes drilled from the ground surface in the direction to the shaft at 10 m distance one to another. Before they set to injection, an exploration borehole was drilled to assess the crater's range and scope of damage. Locations of the injection boreholes and the exploration hole are presented in *Figure 14*.

The crater was filled in four stages.

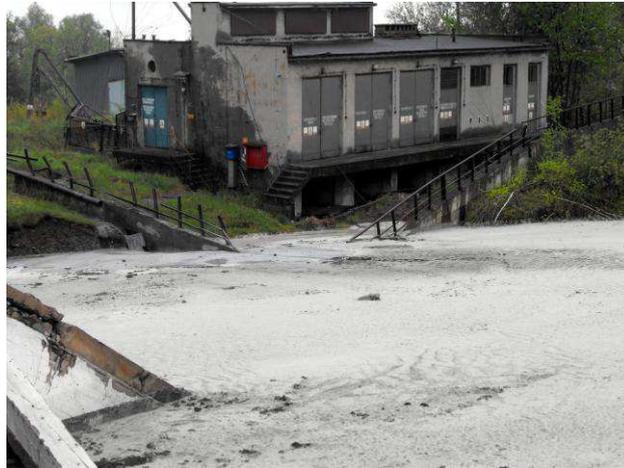
*Figure 15 : The load-bearing layer at the crater – 5 May 2010 (Source: GIG / KWSA)*

*Figure 15 and Figure 16 present results of work performed at Stage II and III.*

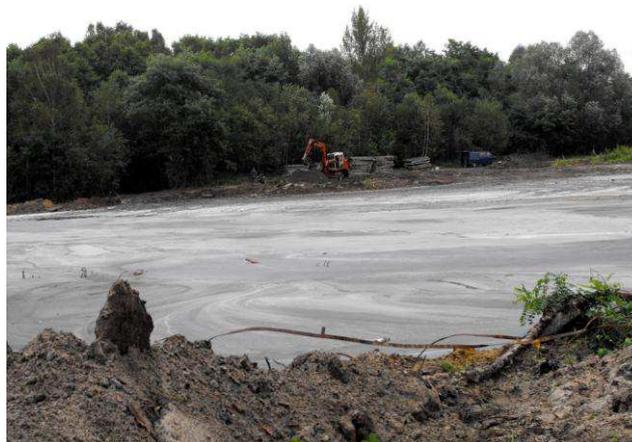
*Figure 16 : Final crater fill with building debris mixed with binding material – 31 August 2010 (Source: GIG / KWSA)*

The third stage (Stage III) included further filling the crater up to the ground surface by means of a mixture of building debris (stemming from demolishing) and a binding material with compression strength of at least 5 MPa. Moreover all fissures that came into being in the vicinity of the crater were filled with the binding material used at the second stage.
