# CNG buses fire safety: learnings from recent accidents in France and Germany

Lionel PERRETTE

Helmut K. Wiedemann

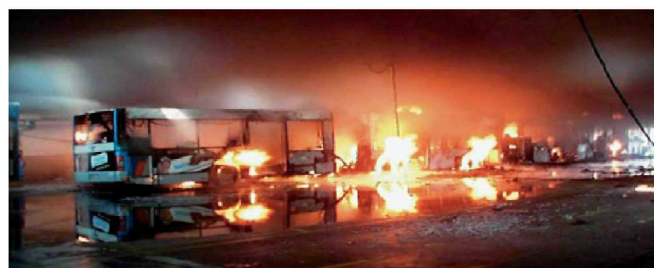
The fire propagated from the back of the first bus to another articulated bus parked in a row at 1.5 meters behind. At 3:09 pm the fire is well developed inside the depot and violent explosions occur. These explosions are caused by the release through actuated PRDs, mixing and later combustion of natural gas inside the depot. Both buses have been burnt out whereas the other ones have been extracted from the depot before they caught fire. The first bus burnt from the back to the front. The second bus burnt the opposite way.

Figure 3: View of the fire once it was under control (from [6])

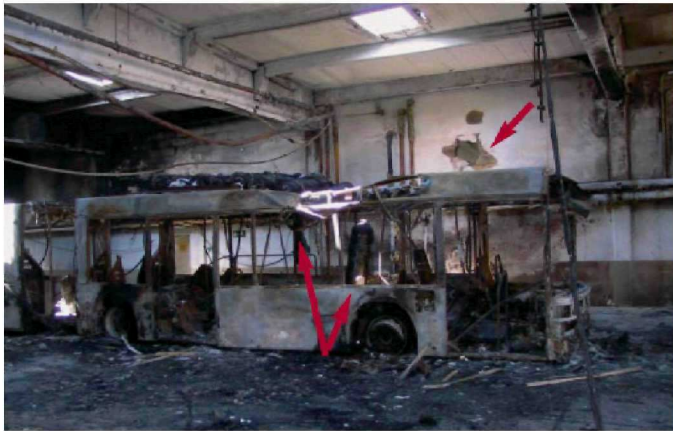
It went a different way for one of the tanks mounted on the second bus whereas the fire was “under control”. The tank burst about 15 minutes after the fire started. A large tank fragment was propelled in the tank axial direction. It broke through a nearby wall (hole at 3 meters from ground level) flew through the air and damaged another wall located 25 meters further and ended up its journey on the roof of a bus parked in a nearby depot. The tank that burst was the first in the row

Figure 4: Destroyed bus with red arrows pointing (from right to left), tank n°3, hanging tank n°2 and hole through which tank n°1 flew (from [6])

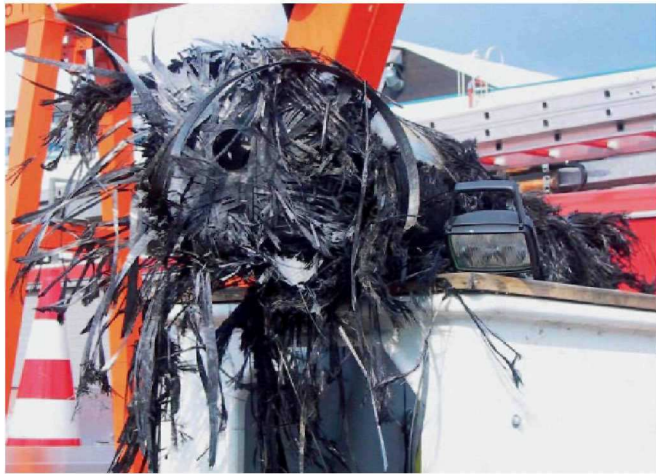
Figure 5: Remains of tank n°1 after it landed (from [6])

Investigation lead to the following explanations. Tank n°1 burst for two concomitant reasons:

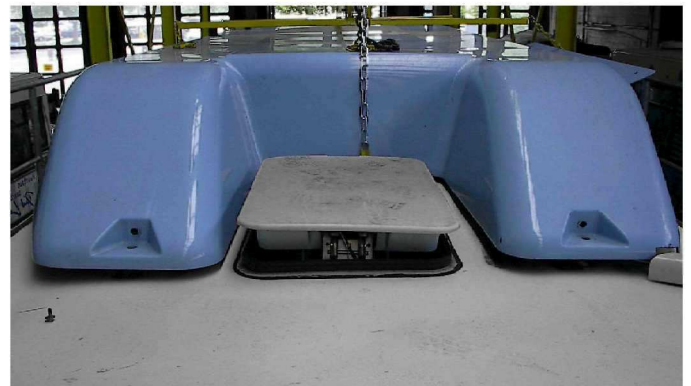
- on one hand it suffered a local fire stress when a fire-induced short-circuit triggered the opening of a roof door mounted nearby tank n°1 (Picture 6). Flame broke through this opening and heated up tank n°1 in its middle part,
- on the other hand, PRDs mounted on tank n°1 did fail to open, hence preventing the tank from depressurising. Investigation concluded that failure to open was caused by an insufficient heat up of the PRDs that did not melt completely. The protective cover mounted on the top of tanks contributed to prevent sufficient heat to reach the PRDs.

Figure 6: Roof opening ahead of tank n°1 (from [6])

Further developments of the current "bonfire test" are necessary in order to consider the entire vehicle as suggested also by [7] & [8]. Besides, any opening underneath or nearby the tank must be avoided (or be sealed and fire resistant). Finally, PRD performance and potential failures should be further investigated including

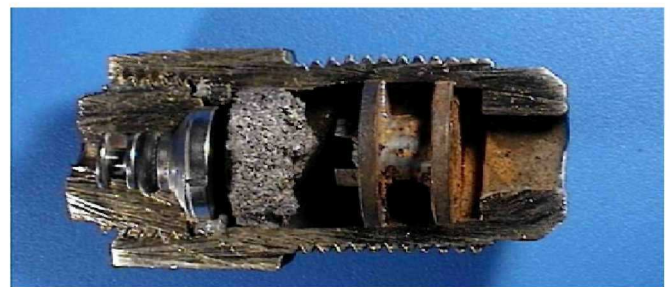
Figure 7: Example of one closed PRD from tank n°1. Picture shows that the metal fuse did not have time to melt completely (from [6])

In that case PRDs did not fail because they froze<sup>3</sup> but because flames heat did not reach them fast enough. Therefore, a tank system that survives a bonfire test may not survive in a real life situation, similarly a fuse that works correctly in test condition may operate differently in real life conditions. Indeed, as the bonfire test only focuses on the tank system and does not consider the entire vehicle, it misses synergetic effects induced by the association of tank system and the vehicle. This remark underlines that tank fire protection and bus fire safety can not rely only on the performance of isolated protected tank systems.

appropriate location that does not shield them from heat or allow them to freeze. As far as freezing is concerned, new PRDs exist with fuse made of glass-cylinders containing expanding liquids. Glass breaks up at 110°C and completely free the release orifice with no possibility of PRD reclosure.

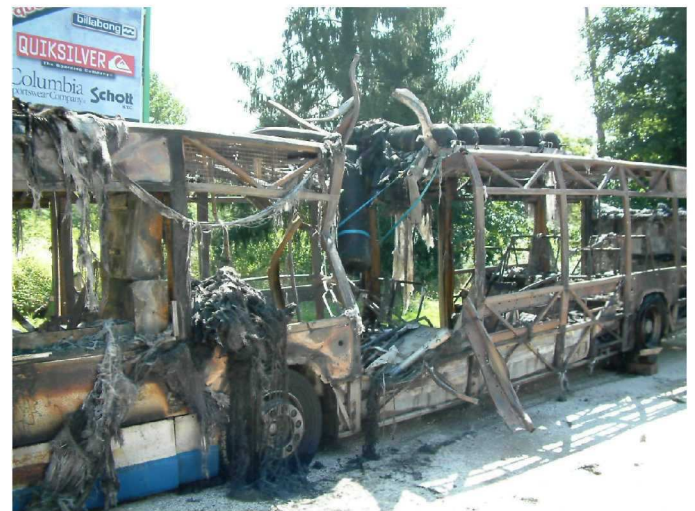
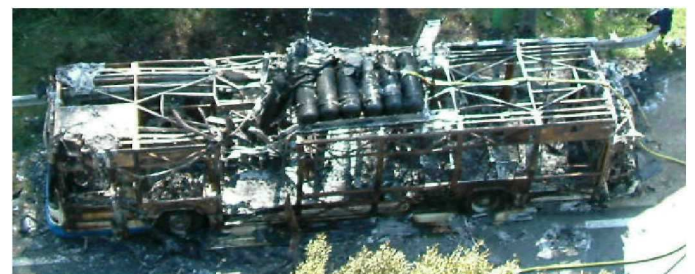
Firemen stood at a safe distance in front of the bus and tried to cool down the tank system with water spray. 10 minutes later at 6:51 am, the front cylinder exploded causing slight and directional damages to the environment within a distance of 100 m. Damages were caused by tank debris (tank n°1 damaged the roof of an adjacent house after a 30 m fly) and overpressure (poster frame unhooked and damaged sliding shutters 60 m away from explosion). As it burst, tank n°1 also propelled the adjacent tank to the other side of the road (10 m away). The tank n°1 ruptured in large pieces whereas carbon fiber could be found as far as 150 m away. Tank n°1 valve and associated fuse have not been found after the accident. Bursting noise could be heard at a 5 km distance. Firemen did not report any noticeable fireball though they felt a transient heat. Nobody was injured.

Figure 10: Top view of the bus (Courtesy SDIS 25)

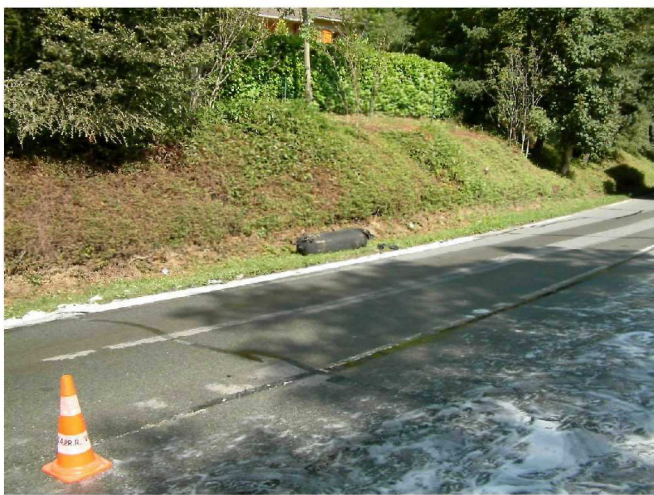
Figure 12: Tank n°2 propelled on the other side of the road (Courtesy SDIS 25)

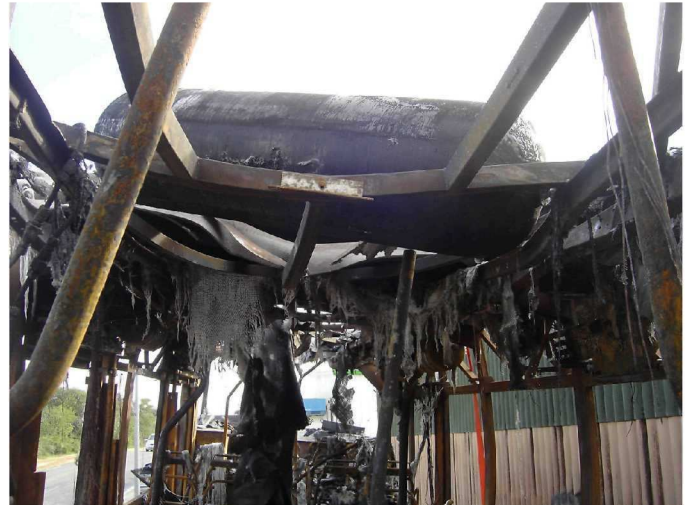
Figure 14: View of tank n°1 that exploded (one half)

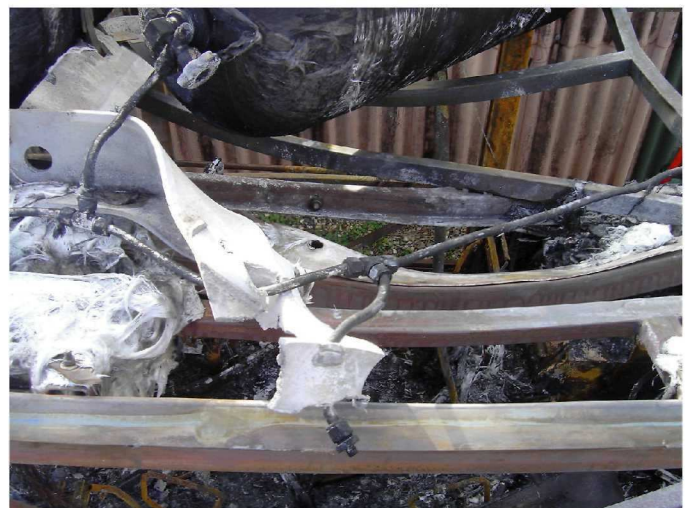
Figure 16: View of the bus from the inside (tank n°2)
