## Treatment of old disused mine openings

Christophe Didier, Francis Wojtkowiak, Romuald Salmon, Jean-Paul Barriere,  
P. Gaget

# TREATMENT OF OLD DISUSED MINE OPENINGS

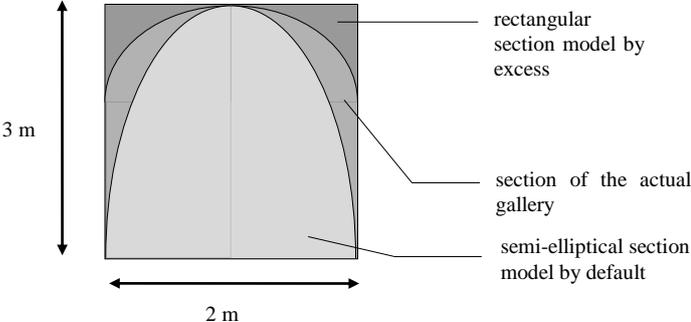
Fig 1 showing the models used for the actual section of Saint-Joseph Gallery

The models used were those of a rectangular and a semi-elliptic gallery to frame the actual result. Calculations showed that the maximum height of a chimney would be between 44 m and 49 m. These yielded quite accurate value and it has been possible to decide from which point no backfill would be required to ensure safety on surface. The same calculations were computed with backfill corresponding to 80% of void volume and to 50% void.

Percentage of void volume backfilled	maximum height of a sinkhole development
0%	44 m - 49 m
50%	23 m - 26 m
80%	10 m

A factor of safety has been chosen taking into consideration the lack of information on parameters as well as the damage potential of surface structures. As two sensitive structures are located above the mine and the thickness of covering materials has been found not to be sufficient, a backfill of the full gallery volume is recommended. As shown on figure 2, it has been possible to propose a « by step » backfilling procedure, each zone backfilled separated from the other by a wall to limit fill dispersion.

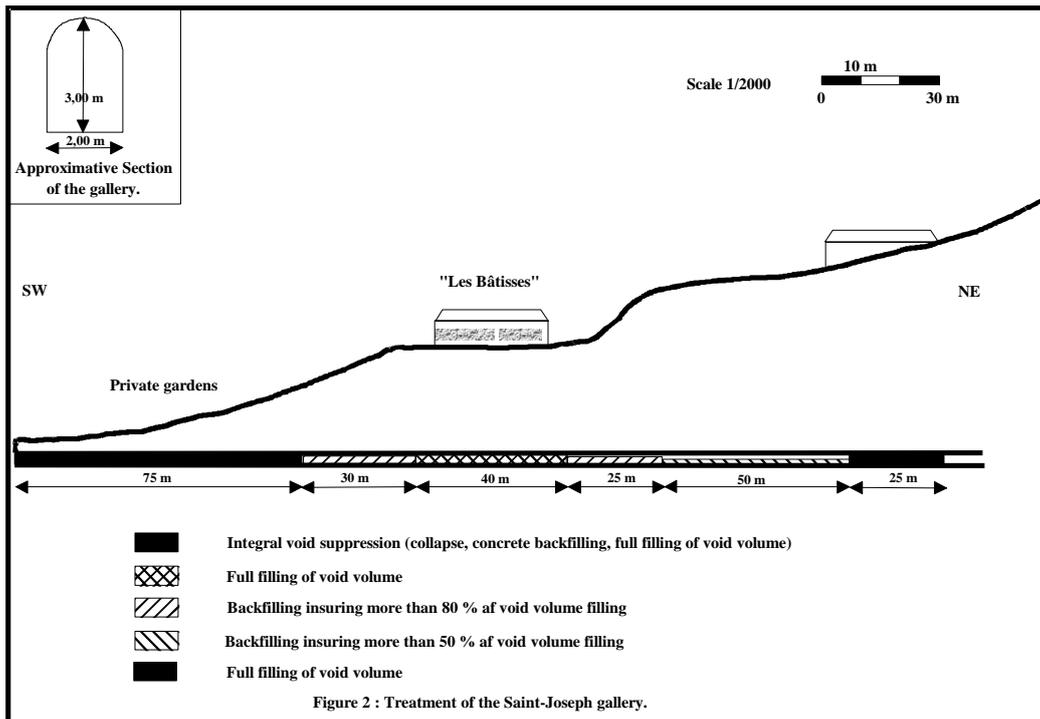
- in the gardens located close to buildings called « Les Bâtisses », one can notice the presence of sandstone with soil. Because of dense vegetation making any visual observation very difficult, it has been assumed that the opening of the gallery was situated within this formation ;
- « Les Bâtisses » were founded on fill made of mining materials. If we assume the height of the fillslope being approximately equal to the thickness of the in-situ layer, it is around 5 m thick (fig 2).
