Analysis of failure in a salt room and pillar mine

Farid Laouafa, Mehdi Ghoreychi

Farid Laouafa, Mehdi Ghoreychi. Analysis of failure in a salt room and pillar mine. 3. International Symposium on Mine Safety Science and Engineering (ISMS 2016), Aug 2016, Montreal, Canada. pp.108-113. ineris-01854254

Institut National de l'Environnement Industriel et des Risques- INERIS, F-60550 Verneuil-en-Halate, France

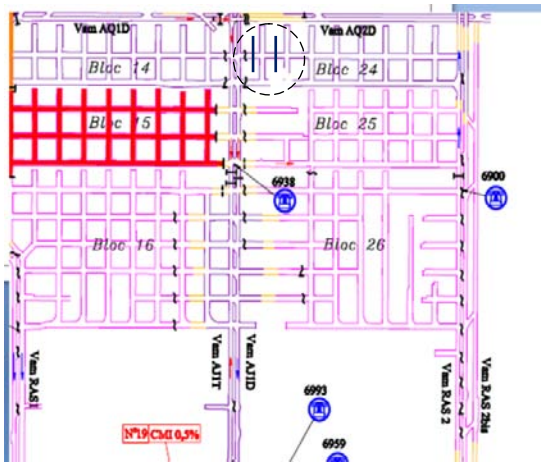
Figure 2: Section through Storage Area and location of cracks (blue) (MDPA, 2015) (Key: Bloc – Block).

The site examined by this study covers an area of about 4 hectares, 700 m x 600 m. It is located at a depth of approximately 550 m and exploited by the classical abandoned room and pillar method. The pillars are 20 m x 20 m square. The chambers are 5.5 m wide and 2.8 m high (Figures 2 and 3). The worked proportion (ratio of excavated surface to total surface) is 38%. Storage is accessible through aisles called double tracks, 4m wide, separated by 3m-wide pillars.

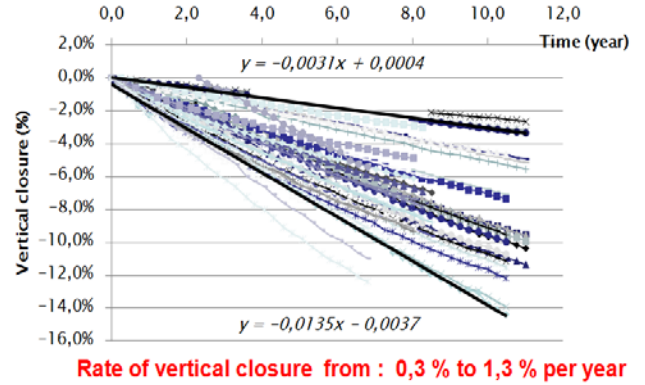
Figure 6: Rate of vertical closure, at different points of the mine (MDPA 2015).

Figure 6 clearly shows the linearity of convergence as a function of time, hence the use of the Norton model described below. For this model, the rate of viscoplastic strain $\underline{\underline{\dot{\epsilon}^{vp}}}$ is expressed as follows (in tensor form):

In light of these main traits of the thermomechanical behaviour of rock salt, two main rheological models have been proposed for the viscoplastic behaviour (creep) of this material: i) The Lemaitre model. According to this model, salt creep slows down over time and its development is expressed by a time power law, ii) the Norton (also called Norton-Hoff) model, widely used for salt throughout the world. This model considers that beyond a short transient phase, creep reaches a stationary state (linear evolution). We would also point out that the Norton and Lemaitre models are designed for the viscoplastic behaviour of rock salt and are not aimed at modelling the damage and rupture of this material. We used in this study the Norton model, on the basis of our findings on the results obtained during a previous study (Laouafa, 2010) focussing on the *in situ* convergence measurements (Figure 6).
