# Analysis of failure in a salt room and pillar mine

Farid Laouafa, Mehdi Ghoreychi

Institut National de l'Environnement Industriel et des Risques- INERIS, F-60550 Verneuil-en-Halate, France

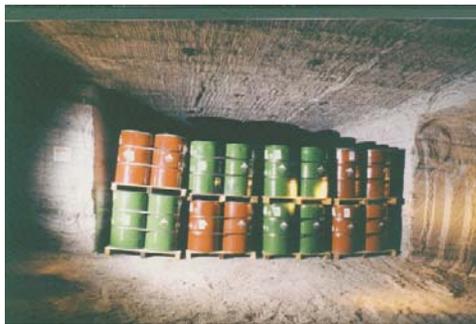
Figure 1: Example of waste storage.

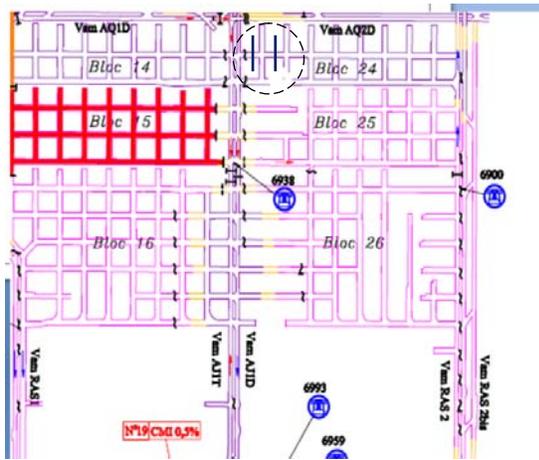
The site examined by this study covers an area of about 4 hectares, 700 m x 600 m. It is located at a depth of approximately 550 m and exploited by the classical abandoned room and pillar method. The pillars are 20 m x 20 m square. The chambers are 5.5 m wide and 2.8 m high (Figures 2 and 3). The worked proportion (ratio of excavated surface to total surface) is 38%. Storage is accessible through aisles called double tracks, 4m wide, separated by 3m-wide pillars.

Figure 2: Section through Storage Area and location of cracks (blue) (MDPA, 2015) (Key: Bloc – Block).

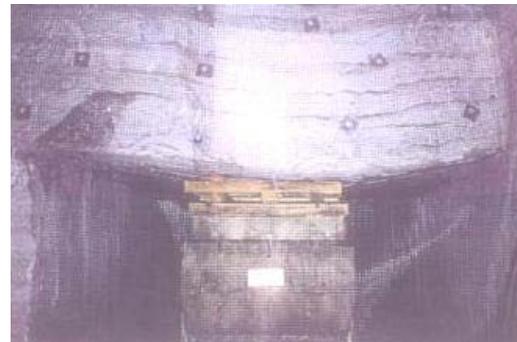
Figure 5: Example of separation of roof (source, MDP A 2015).

As for bed separation (Figure 5), this affects the bed of rock salt in the roof immediately above the

tracks at the marly-anhydrite insoluble interlayers that are frequent at MDPA site.
