Analysis of Faults' Effect on the Stability of Surface Lignite Mining Areas Using the Distinct Element Method

Marwan Al Heib, Ioannis Zevgolis, Alexandros Theocharis, Nikolaos Koukouzas, Stella Coccia

Marwan Al Heib, Ioannis Zevgolis, Alexandros Theocharis, Nikolaos Koukouzas, Stella Coccia. Analysis of Faults' Effect on the Stability of Surface Lignite Mining Areas Using the Distinct Element Method. Geotechnical and Geological Engineering, 2021, 10.1007/s10706-021-01964-z . ineris-03337490

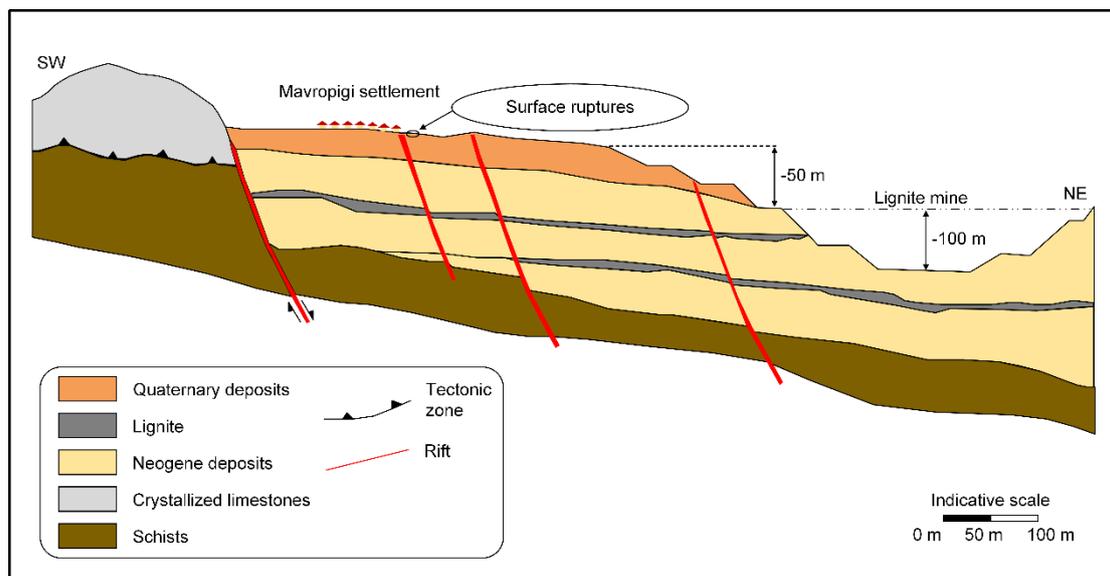
Figure 1: Simplified cross-section of the Mavropigi open coal mine (Kalogirou et al. 2014; Marinos et al. 2015)

Kalogirou et al. (2014) proposed a more comprehensive geological model for the case study (Figure 1). Based on this model, Marinos et al. (2015) performed a finite element analysis to simulate the deformations, the shear and tensile failures, and evaluate the exact mechanism of failure. They concluded that the cracks, the displacements, and the slide failures were connected with the open-pit lignite mine's exploitation. Zevgolis et al. (2015) summarised the most critical parameters related to slope stability and ground subsidence in the Mavropigi mine: the excavation progress's adverse geometry, the geotechnical parameters of the soil formations, the interfaces between layers, and the faults. They also presented a finite element analysis, incorporating the geologic faults as interfaces.

Initially, the typical profile of the case study is analysed. Figure 1 presents a simplified cross-section of the Mavropigi open coal mine (Kalogirou et al. 2014; Marinos et al. 2015). This cross-section illustrates the various geological layers, their appearance and the

existence of faults. In total, four faults roughly parallel to the open pit slope cross the horizontal soil layers. Two of them are specific, while the other two are probable. Similar results could be derived from Steiakakis et al. (2017), but these authors presented a slightly different cross-section from another part of the slopes.

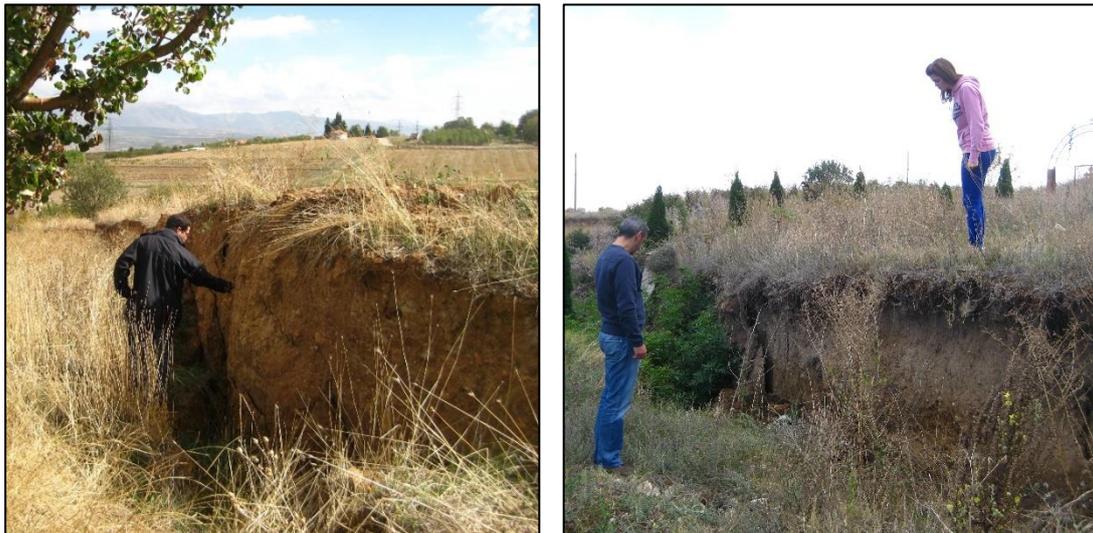
Figure 2: Severe cracks between the mine and the Mavropigi village (October 2013)

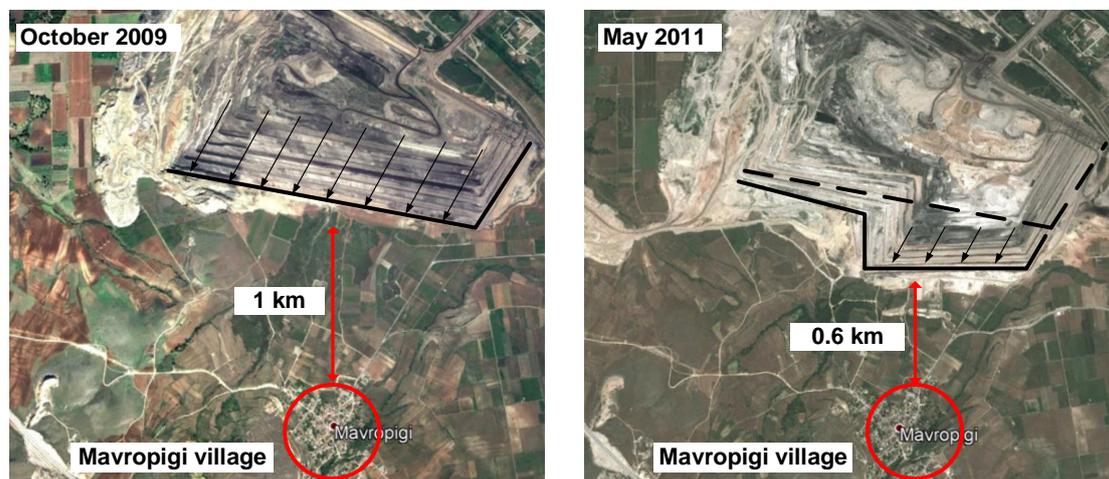
Figure 3: Progress of excavation due to land acquisition issues (a) the excavation with black lines until October 2009 and (b) the excavation progress with black lines until May 2011 and its adverse geometry

Several reasons were recognised to be behind the significant movements (Papadaki et al. 2013). Firstly, during mine operations in 2009-2010, the excavation progressed in a non-conventional way due to expropriation limitations. Delays in the land acquisition of a small area in front of the excavation face caused trouble in the production and imposed significant changes in the excavation direction (Roumpos and Papacosta 2013). These changes created an adverse steeply convex geometry in the excavation face with adverse geotechnical effects and decreased the distance to the village more rapidly than planned (Figure 3).

The tension cracks and settlements had consequences on the progress of the mining operations but also on the nearby village (Figure 3). Initially, the mining plan changed. Detailed monitoring and studies allowed for the continuation of the mining operations on the sliding mass; that was a challenging problem that demanded extra caution (Steiakakis et al. 2017). More specific are the consequences in the nearby village. When the first ground cracks were observed, light damages had already been detected in some buildings. Notice that 85% of the buildings were residential (with the remaining being either warehouses or abandoned), made from reinforced concrete, bricks/concrete blocks, and stone masonry. Most of the buildings had either only a ground floor or two stories, while a few buildings had a ground floor with a basement. Two inspections (2011 and 2017) from different public bodies took place to detect and record building damages at the local

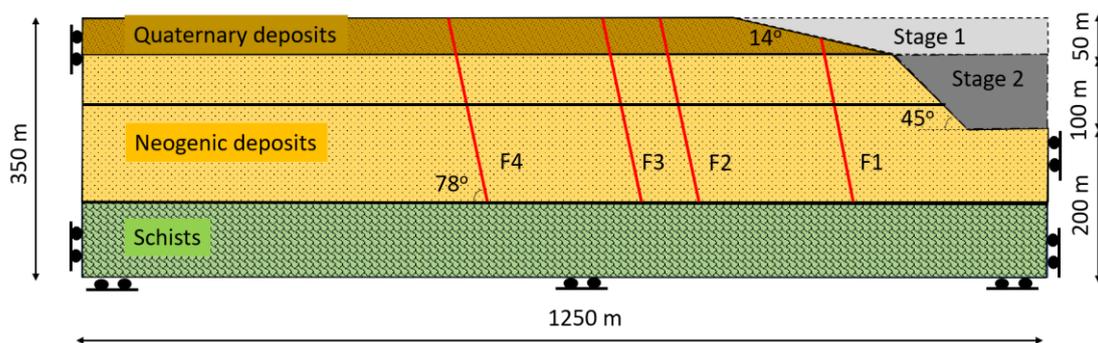
Figure 4: UDEC model, boundary conditions and excavations stages

Figure 4 presents the 2D numerical model. The numerical model dimensions were finalised after a trial-and-error investigation to avoid boundary effects, focusing mainly to avoid interactions between faults and boundaries. Boundaries (especially the left boundary of Figure 4) that were not far enough from the faults influenced the results; the right boundary has been chosen based on the fault F1 and the slope's evolution during the excavation of stages 1 and 2. The final model dimensions were 1250m × 350m. The benches of the actual geometry were omitted as they are not crucial for the present investigation that focuses on overall slope analysis and especially on the effects of the faults.

Geostatic conditions were calculated, and two excavation stages of 50 (stage 1) and 100m (stage 2) were presumed, resulting in a mine 150m deep. Series of parametric studies were performed to overcome the data limitation and study the effects of the various parameters that eventually resulted in eight different models (Table 4). The effect of six parameters was investigated with a focus on the effect of faults on the results. Thus, the analyses are discussed with and without faults, with and without lignite layers, with different lignite layers' inclinations, two faults' stiffness ratios, faults' strength, and different initial earth pressure.

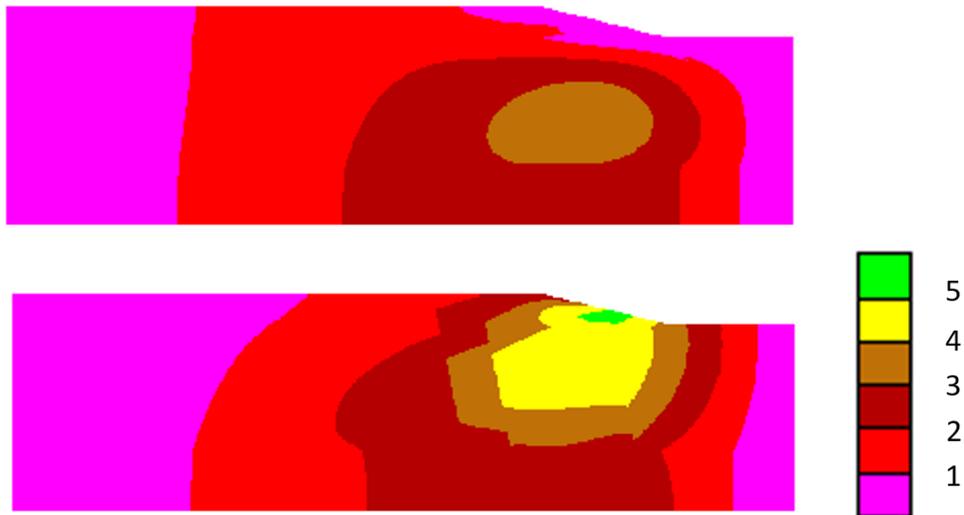
Figure 5: Horizontal displacements (cm) for the configurations (bottom) M1 with and (top) M0 without faults for stage 1

Initially, the two identical base models, one without (M0) and one with faults (M1), are compared. Figure 5 and Figure 6 present the horizontal displacement of the rockmass for the two configurations with and without faults and for the excavation stages at 50m (stage 1) and 150m (stage 2), respectively. The faults' existence modified the horizontal and vertical displacements, increasing their magnitude. Additionally, the faults' locations are visible on the displacements (horizontal and vertical) due to the discontinuities on their spatial distributions. The maximum horizontal displacement increased by 43% for stage 1 (from 35mm to 50mm) and 25% for stage 2 (from 80mm to 100mm).

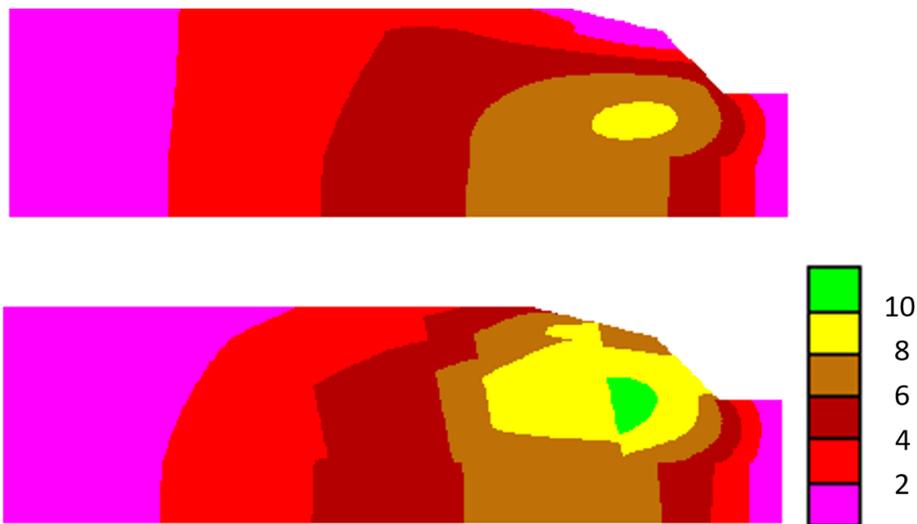
Figure 6: Horizontal displacements (cm) for the configurations (bottom) M1 with and (top) M0 without faults for stage 2

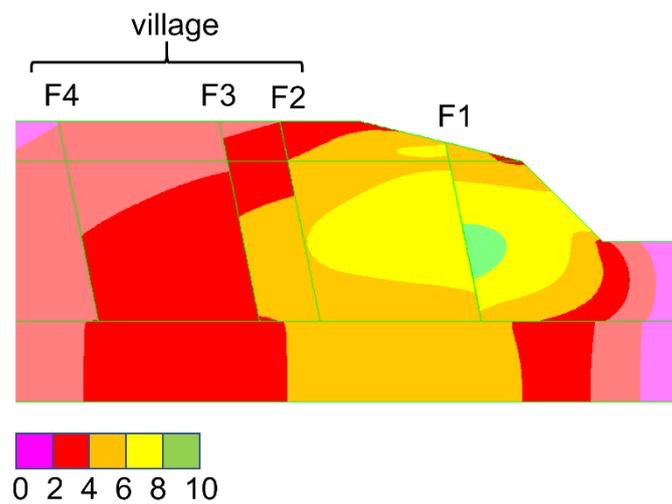
Figure 7: Horizontal displacements (cm) induced by the total excavation (M1) - stage 2 - Faults F1 to F4

Furthermore, Figure 7 presents the horizontal displacements for stage 2, including faults and highlighting their location and the village's location. Horizontal displacements in the village zone vary between 1cm and 4cm. Similarly, Figure 8 presents the vertical displacements for the same stage. The vertical displacement magnitude varies from -4cm (downwards) to +6cm (upwards), implying differential displacements and open cracks in the area. The three closer-to-the-village faults (F2, F3 and F4) create an apparent

disruption of the displacements' distribution. The discontinuities of the horizontal displacements are visible on the surface and are consistent with those observed in situ (Marinos et al. 2015; Steiakakis et al. 2017).

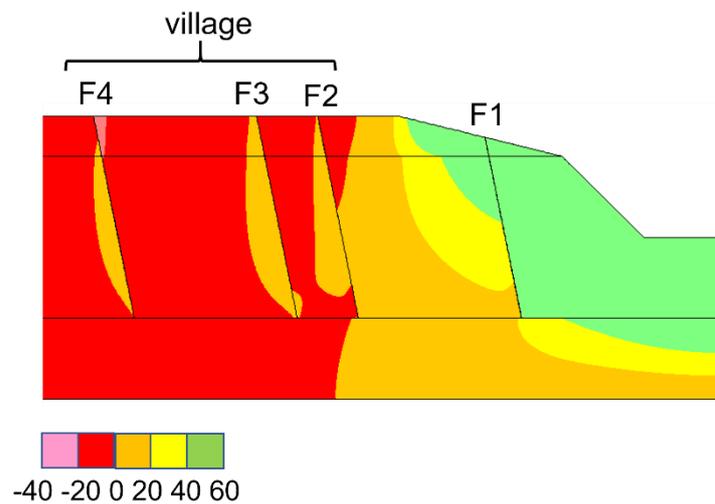
Figure 8: Vertical displacements (cm) induced by the total excavation (M1) - stage 2 - Faults F1 to F4

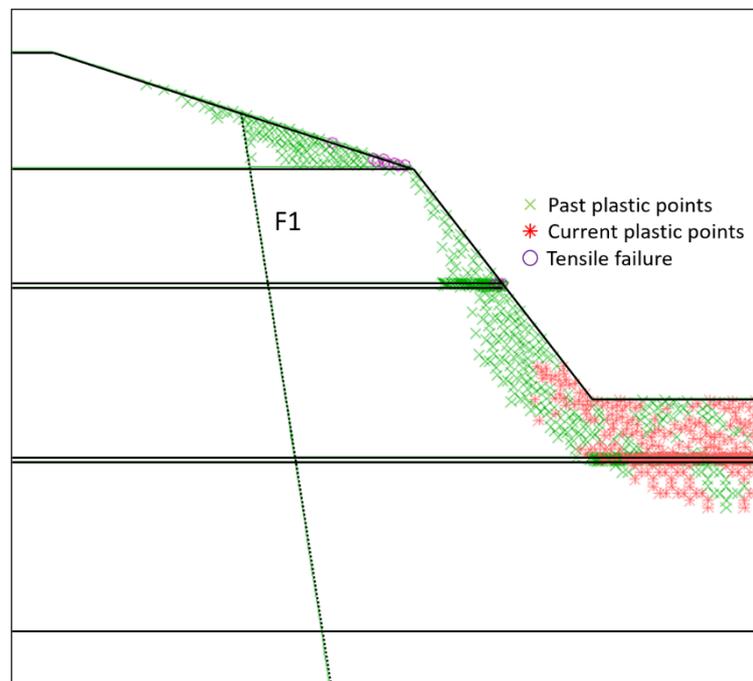
Figure 9: Plastic zones (red and green) and tensile failure (purple) induced by the total mine excavation (M1) – stage 2, F1 (first fault)

Figure 9 illustrates the plasticity developed within the soil mass for the second excavation stage of model M1, this being a reference model-stage of the analysis. More specifically,

“x” (in green) indicates that a plastic state was reached during a former calculation cycle, “*” (in red) indicates that the current stress state is in the plastic range, and “o” (in purple) indicates a current tensile failure. The plastic points (current or past) lie near the slope’s edge as stress changes are more significant. **This plastic area tentatively corresponds to the unstable zone of the slope. Although few of the past plastic points might be an artifact of the numerical analysis, the trend suggests a plasticity concentration at the bottom, crest, and near the edge of the slope.**

The role of the lignite layers' presence and inclination was investigated through models M1, M2 and M3. These layers were considered as discontinuities for the numerical analysis with properties same to these of the faults. Model M1 considered a 15° inclination of the lignite layers, model M2 horizontal lignite layers (zero inclination), and model M3 did not include any lignite layer. No significant effect of the lignite layers was noted on the results. The plastic zones' number vaguely increased with the lignite layer's existence and smaller inclination, mainly due to the interface's effect that offered a way for plasticity to move deeper in the slope (e.g. see Figure 9).

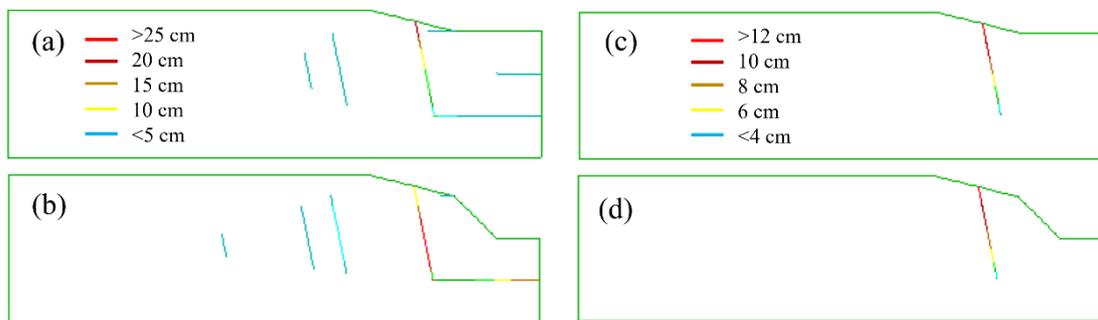
Figure 10: (a) and (b) normal and (c) and (d) shear displacements of the faults at the two stages of the excavation (M1). (a) and (c) are results for stage 1 and (b) and (d) for stage 2.

Additional information about the response of the faults, particularly their shear and normal forces and displacements developed during the two stages, can be investigated due to the discrete nature of the simulation. Figure 10 presents the shear and normal displacements of the faults and depicts that the open-pit excavation activated the faults by inducing shear and normal displacements on large zones. The shear displacement concerns only the fault that is very close to the excavation (F1), but it has a large maximum

shear displacement of 161mm (Figure 10(d)). On the contrary, three faults are opened (normal displacements) during the first stage, and all four faults - lying up to 400m away from the excavation - during the second stage. The maximum horizontal opening of the faults equals 37.3mm (Figure 10(b)). This “opening displacement” is essential as it possibly caused the open cracks on the surface. Moreover, the intersection between the coal/clay layers and the faults could form a composite surface and trigger a substantial sliding mass. Thus, two potential sliding wedges can be considered: one on the mines’ slopes and another in the area surrounding the faults.

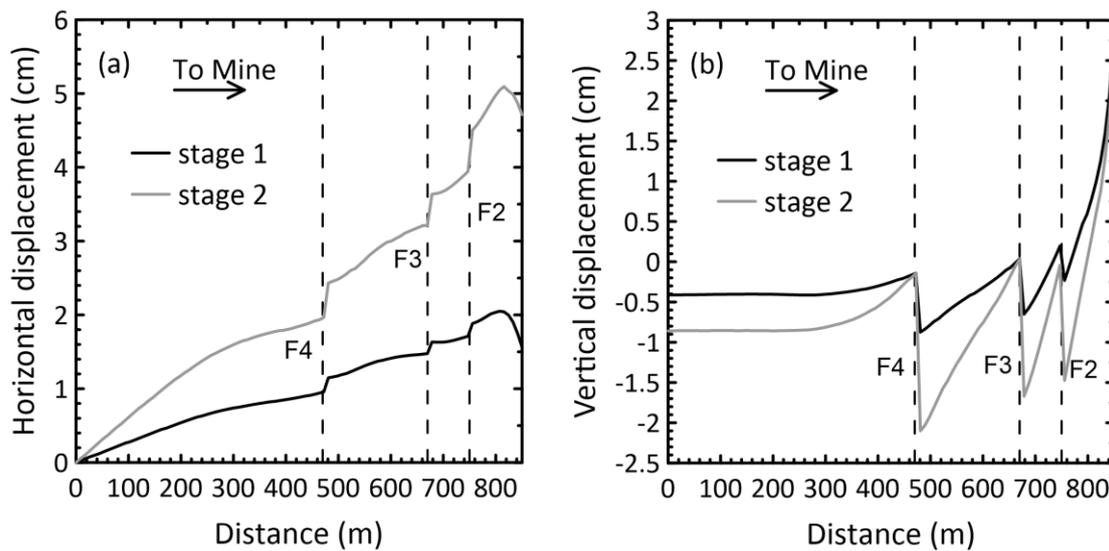
Figure 11: Horizontal (a) and vertical (b) displacements at the ground surface for the two stages of the excavation (M1)

Figure 11 presents the profiles of horizontal and vertical displacements at the ground surface for the two excavation stages of model M1. As commonly for excavations, near the mine’s slope, an uplift is observed, similarly to the upwards movements of Figure 8. When the excavation occurred, the floor and sides of the excavations move upward, being unloaded; this movement is herein rather intense as a Mohr-Coulomb constitutive law was used, having a constant stiffness and lacking distinction between initial loading and unloading.

The effect of faults is evident and is illustrated as an abrupt change in the displacement curve. As expected, the displacements are larger near the mine and generally diminish

further away. However, the horizontal displacement slightly increases whenever approaching a fault and then abruptly decreases while the vertical displacement drastically increases due to the fault movement. These rapid changes can produce surface cracks and large differential settlements and are catastrophic for infrastructure and buildings, as were for the village. The differential settlement around the fault F4 is more than 20mm (-20mm in Figure 11), and it is large, indicating potential damage to any construction near this area.

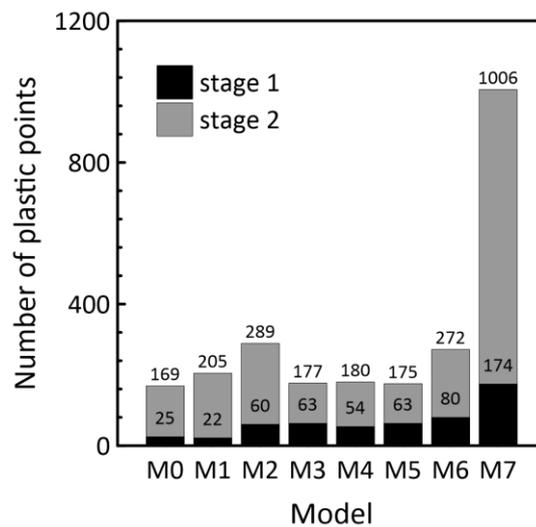
Figure 12: Number of developed plastic points for the eight models (M0 to M7) and the two excavation stages (stage 1 and stage 2)

The number of plastic zones increased due to the faults when comparing M0 to M1 (from 169 to 205, a 20% increase). The maximum vertical and horizontal displacements were located in both models practically at the edge of the excavation slope and were not affected by the faults, as expected. Nevertheless, significant vertical and horizontal displacements were observed in the village area, as previously noted (Figure 7 and Figure 8). The maximum shear displacement of the faults was 9.7cm, and such a large fault displacement would significantly affect the adjacent areas.

number of developed plastic zones increased with the increase of K_0 (205, 272, and 1006, see Figure 12); as the initial horizontal stresses were larger for $K_0=1$ when the excavation took place, a greater imbalance was created with larger horizontal stresses “pushing” towards the excavation, leading to a larger plastic area. For the same reason, the maximum horizontal displacement drastically increased with the K_0 increase (9.6, 13.2 and 37cm). Faults’ shear displacements were affected by the same mechanism and increased with K_0 (9.7 vs 14.4 vs 20.7cm), while the maximum vertical stress also increases but slightly.

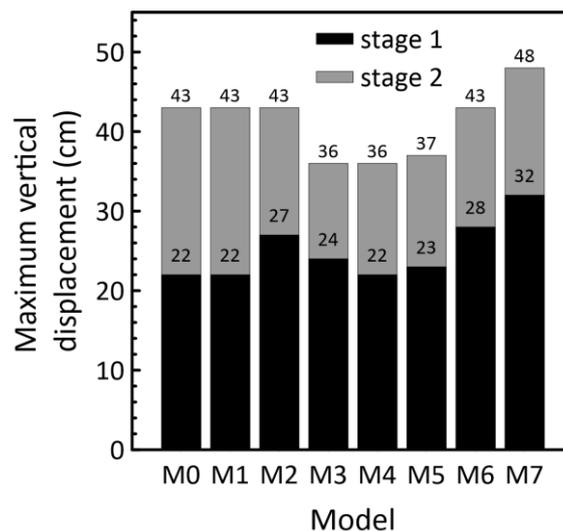
Figure 13: Maximum vertical displacement (cm) for the eight models (M0 to M7) and the two excavation stages (stage 1 and stage 2)

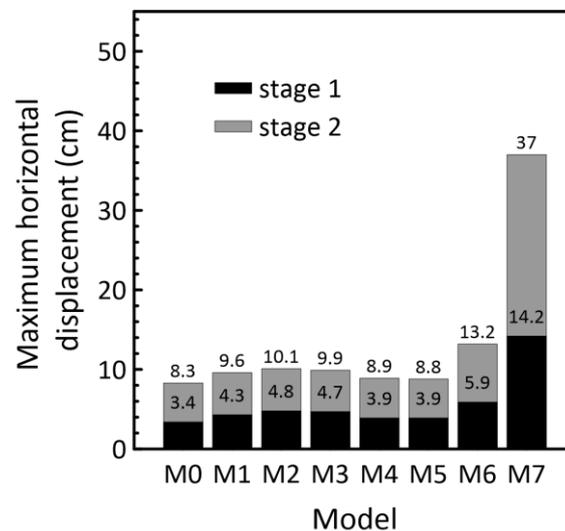
Figure 14. Maximum horizontal displacement for the eight models and the two excavation stages

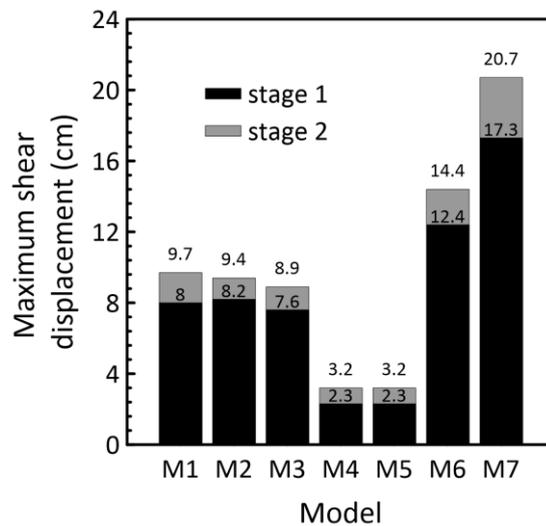
Figure 15. Maximum shear displacement of the faults for the eight models and the two excavation steps

Figure 15 validates this result as the faults' shear displacements were significantly affected by the k_n/k_s ratio. The maximum shear displacement after the second excavation stage was almost 9cm for M3 (for lower $k_s = 0.66\text{MPa/m}$) vs slightly above 3cm for M4 (for higher $k_s = 6.6\text{MPa/m}$). The number of plastic zones and the maximum vertical and horizontal displacements of the open-pit slopes were not affected by the faults' stiffness. However, the difference in the faults' shear displacements crucially affected the village area's settlements, away from the slope. Additionally, the plastic zones and mass displacements are more related to the local effects of the excavation.
