## Case studies and analysis of mine shafts incidents in Europe

Amélie Lecomte, Romuald Salmon, W. Yang, Alec Marshall, M. Purvis, S. Prusek, Slawomir Bock, L. Gajda, J. Dziura, Agustin Munos Niharra

### **Abstract**

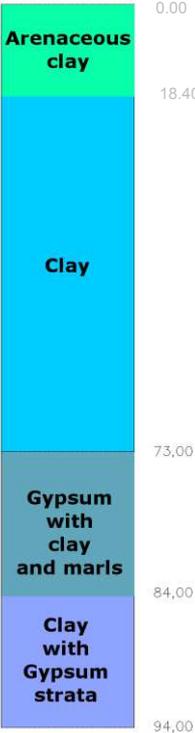
The Tertiary formations with a thickness of about 120 m mainly occurring in a form of hard-plastic clays are prone to swelling under water influence. At depths from 73 m to 84 m the clays are interbedded with gypsum and marls. Below in an interval from 142 m to 146 m and 161 m to 165 m (i.e. up to the Carboniferous top) fine-grained sandstones, arenaceous dusts with interbeddings and interlayers of water-bearing dusty sand with a small thickness and prone to become liquid.

The Carboniferous formations are composed of strata of argillaceous shales, arenaceous shales and sandstones, among which coal seams with a thickness of up to 4.5 m occur. A fragment of geological cross-section along shaft V is presented in *Figure 12*. It represents the geological setting in the area of the catastrophe.

*Figure 12 : Geological cross-section in the area of catastrophe occurrence*

The primary cause of the accident at the shaft was damage to its lining at a depth of 61 m – 67 m. The damage was a consequence of:
