# CNG buses fire safety: learnings from recent accidents in France and Germany

Lionel PERRETTE

Helmut K. Wiedemann

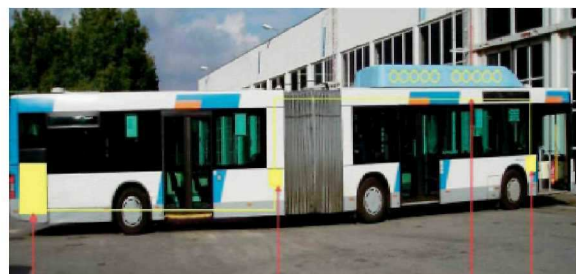
The fire started on a CNG articulated bus in the engine compartment (back of the bus). When the fire took off at 3:00 pm, the bus was parked in a depot along with other

CNG articulated buses. Each articulated bus was fitted with 10 CNG type III PRD protected tanks of 172 L each and filled with natural gas at a pressure of 200 bar.

Figure 2: Side picture of a bus similar the ones that burned (from [6])

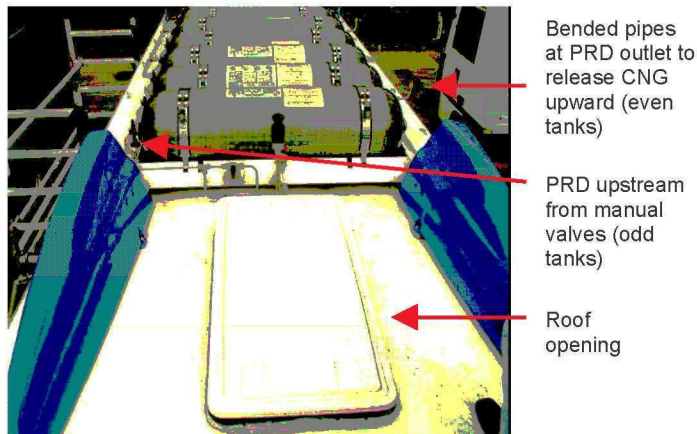
A 12 meter CNG bus was in daily commercial service on the 1<sup>st</sup> of August 2005. This bus was equipped with nine 126 L, 200 bar working pressure type IV CNG tanks. Each of the nine tanks was fitted with one thermal fuse located alternatively on the right or on the left side of the bus. There were two other thermal fuses located respectively ahead and behind the tank system. These two fuses are supposed to open before the fire reaches the tank system (from the front or the rear of the bus).

One single valve isolates the entire tank system from downstream components which means that when the valve is closed the tanks remained connected one to the others. The only way to isolate one tank from the others is to shut down its manual valve. Gas release deviators pointing upwards are mounted on the PRDs outlet in order to discharge CNG in the upward direction.

Figure 8: Top view of a CNG bus of a similar type to the one that caught fire (tank cover has been removed for taking the picture)
