Methods applied to investigate the major UVCE that occurred in the TOTAL refiner's Fluid Catalytic Cracking Unit at La Mède, France

P. Michaelis, A. Hodin, Jean-François Lechaudel, P. Mejean

Methods applied to investigate the major UVCE that occurred in the TOTAL refinery's Fluid Catalytic Cracking Unit at La Mède, France.

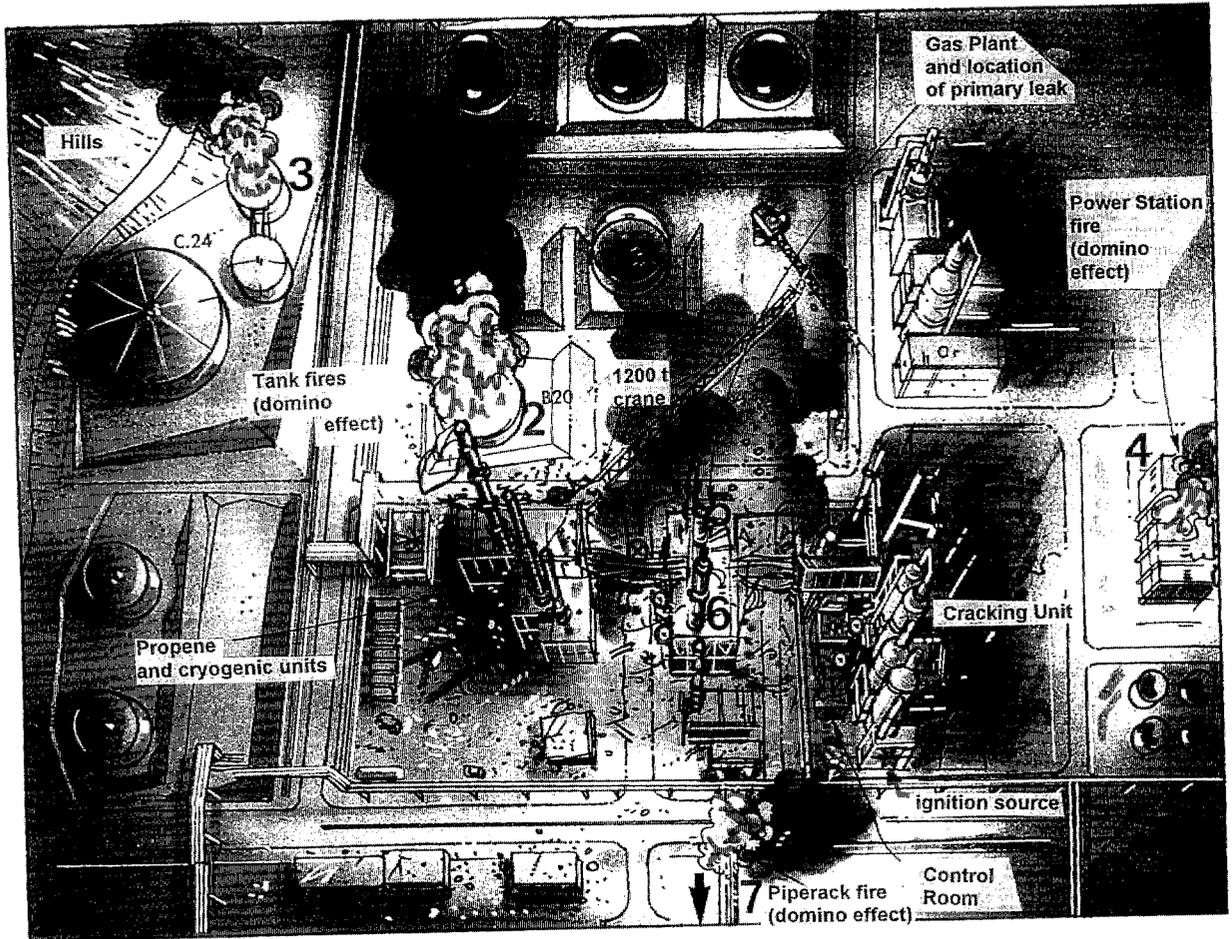
Figure 1. Chronology of Events **X** epicentre **3** location of victims

On Monday November 9, 1992 at 5:20 a.m. a major U.V.C.E. occurred in the Gas Plant of the TOTAL refinery's Fluid Catalytic Cracking Unit at La Mède, France. The origin was a 25 cm² break in the 8" by-pass of the absorber stripper column cooler; an amount of about 15 tons of LPG and light naphtha was released within 10 minutes, covering an area of 14000m² including Gas Plant, cryogenic, propene and Merox units before being ignited on the FCC main furnace. There were eight people on shift in the unit: 6 died, one was very seriously injured, and one slightly injured. The total loss including loss of production is estimated at 600,000,000\$. (see figure 1)

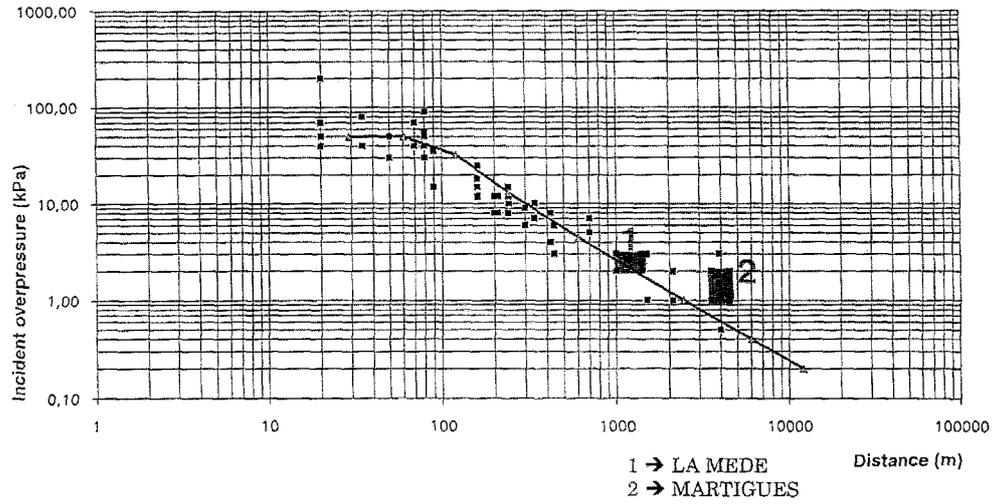
Figure 4. Multi-energy approach: correlation with observed damages corresponding to an hemispherical cloud with a 29m radius.

One may think that the damages behind the refinery fence, in particular at Martigues, were enhanced due to the meteorological conditions at the time of the explosion. As a first step, the explosion damage analysis allows to determine the epicentre area of the explosion. This area is defined as the location where the pressure was the highest. This epicentre area was located between the propene unit and the Gas Plant. It is different from the ignition point and from the origin of the leak, because the explosion pressure depends strongly on the congested parts on the site. (see photograph of figure 3) As a second step, the examination of the projection of missiles allows to evaluate the pressure at the epicentre area: 50 to 200 kPa locally. Then, several methods were used to determine the amount of flammable mixture involved in the explosion: TNT equivalency, multi-energy method and spherical expanding flame model. For example, the multi-energy method allows to make some comparison between the congested volume from the different units and the damages observed. The objective was to obtain the better curve as possible to reduce the distance between the curve and the damage points (see figure 4). Finally, the different methods led to good agreement about the assessment of the most probable amount of flammable mixture involved in the explosion. The best estimation was about 5 tons scale of sizes.

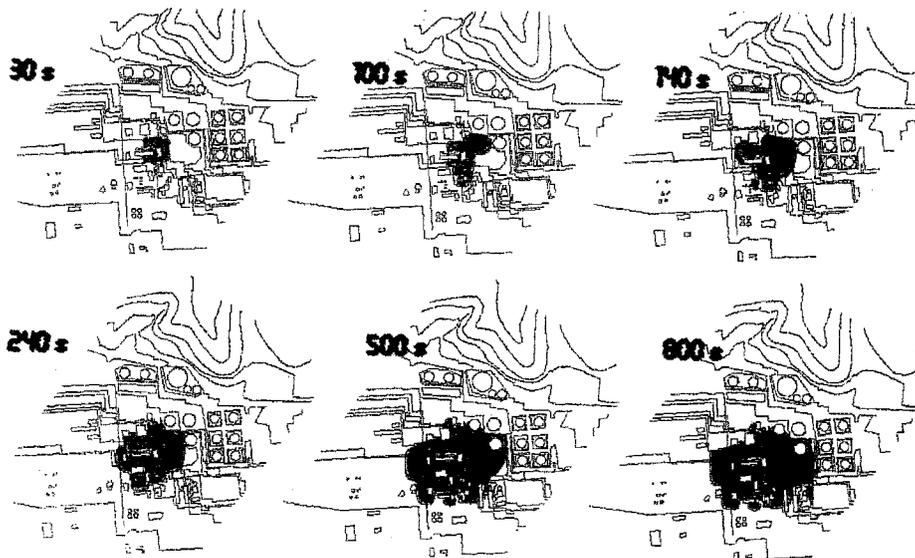
Figure 7. Wind tunnel simulation: dispersion and transport of the vapour cloud (8" by-pass case) as a function of time.

This definition of the Richardson number, used by Köning-Langlo and Schatzmann (1990) is routinely used for continuous releases in a calm atmosphere, characterized by wind speeds under 1 m/s. A different definition is used for non-zero wind velocities, where the local flow velocity is used to determine the characteristic scales (Britter and McQuaid 1988). Validation tests, presented in particular by Köning-Langlo et al (1990) Hall et al (1982) and Y. Riou (1987), have shown good agreement of the wind tunnel results with those obtained in situ, mainly at Thorney Island (MC Quaid 1984), Porton (Picknett 1978, 1981) for instantaneous gas releases and at Burro (Koopmann et al 1982), Maplin Sands (Puttock) et al 1982) and Thorney Island for continuous gas releases. Instantaneous concentrations are measured by means of a hydrocarbide analyzer (Cambustion Ltd) the passband of which is about 500 Hz for a 150 mm sampling probe length. The tracer gases used in the wind tunnel are mainly hydrocarbides whose densities are close to the considered release conditions. The main test results for the three scenarios under consideration have shown, despite the very conservative hypotheses adopted for this simulation, that the maximum gas leak from storage tank C24 could not be the cause of the accident, since the concentration levels reached at the ignition point are far lower than the gas inflammability limit (LEL). Regarding the two absorber stripper cooler EA 103 scenarios, the tests showed that scenario break at the by-pass bounds the second one (failure of 1" branch connection). The gas concentrations at the ignition point (furnace F 301) only reach the LEL for the first scenario. The simulation made for this scenario by east wind led to the results closest to the evidence. Note in particular that the gas cloud reaches both the gas detector P80-1 and the ignition source. The dispersion and transport of the gas cloud particularly made it possible first, to characterize the progression of the explosive mixture as far as the presumed ignition source and, secondly, to evaluate the average time to reach the ignition point by the LEL at 675 ± 110 seconds for 98 simulations, compatible with the estimations made elsewhere (see figure 7).
