## Back-analysis of the rockburst in Frieda 5 and design program for panel in seam 6 (HBL-France)

Vincent Renaud, Lynda Driad, Marwan Al Heib, J.-F. Noirel

Vincent Renaud, Lynda Driad, Marwan Al Heib, J.-F. Noirel. Back-analysis of the rockburst in Frieda 5 and design program for panel in seam 6 (HBL-France). ROCKBURSTS International Symposium 2002, Nov 2002, Ustron, Poland. pp.313-326. ineris-00972385

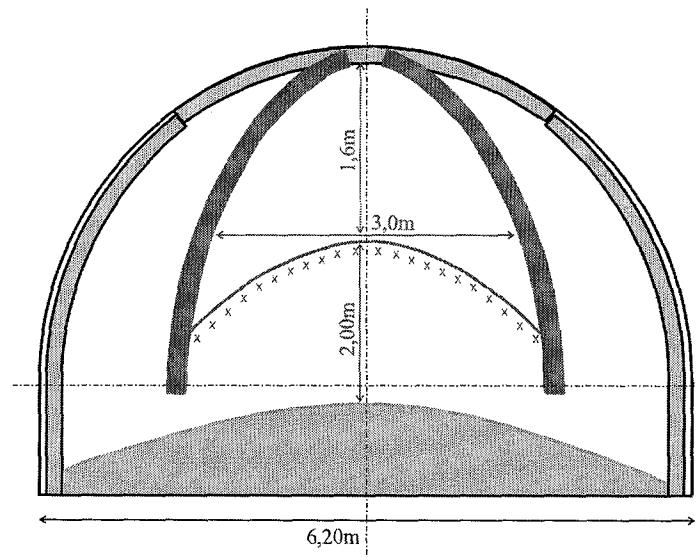
Fig. 1: Diagram showing bottom level blow off.

On June 21 2001, a fatal rock burst affected the main gate of the Frieda 5-1250 panel in the Merlebach Mine (HBL). The rock burst was extremely violent (magnitude 3.6). The heave exceeded 2 m (figures 1 and 2, HBL note number 384/01-JPA/ND [3]). The damaged zone was 250 m long and was located at between 100 m and 350 m in front of the face (between the sides).

The seismic focus of the 21/06/01 event is located on the Frieda5 main gate 100 m in front of the face (figure 1). The location in depth shows that the depth of the focus of this event is about 1400 m (estimated depth below the surface, figure 2) at 200 m from the Frieda5 cutting face.

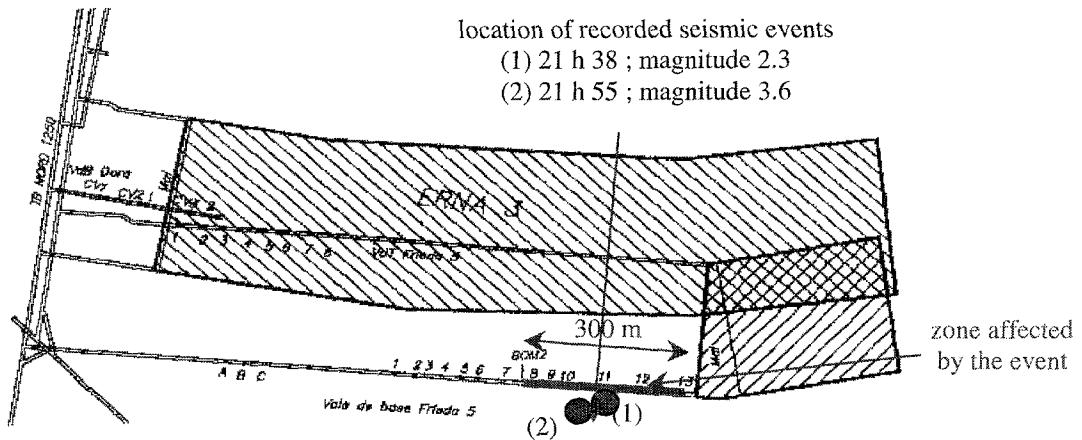
In the case of the June 21 2001 event, the analysis of the direction of the first movement demonstrated an explosive rupture mechanism. More explicitly, the movement of the wave was a pure compression. Events recorded before the accident, and particularly the 21/06/2001 event at 19h 38 (~ 20 min before the accident), show a shear mechanism (figure 2).

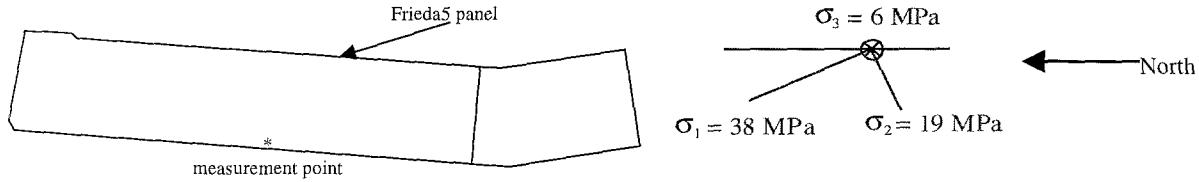
Fig. 4: Stress diagram in accident zone

Stress measurements show that horizontal stresses are very high and the vertical stress is less than the weight of the ground (figure 4).

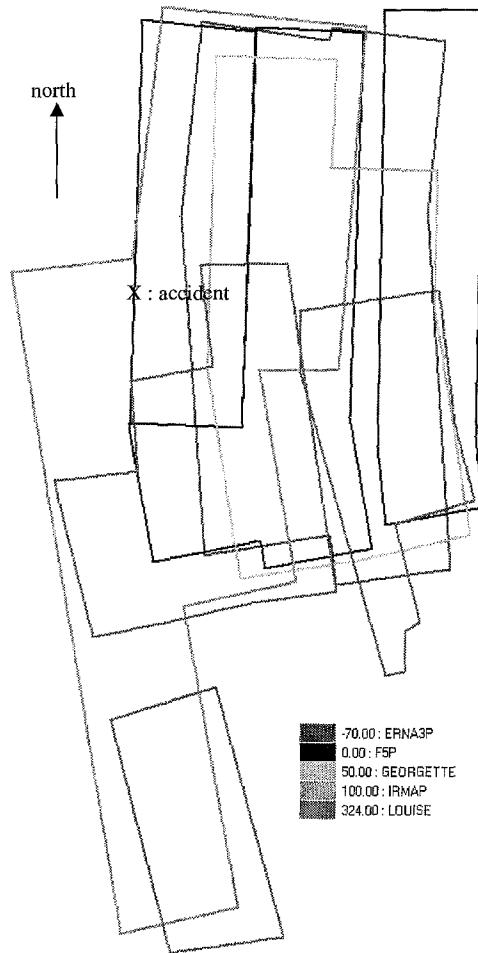
Fig. 5: Modeled seams with SUIT3D

The model using the SUIT3D program ([8], figure 5) was intended to achieve two objectives, firstly to find the initial tensor before mining started, and variations in the stress tensor close to the area of the accident [2]. The calculation was made assuming linear elasticity, with an isotropic stress tensor over the scale of the deposit. The seams considered in the calculation are shown in table 1.

- mining operations in the Irma-1250 panel considerably modified the distribution of normal, horizontal and axial stresses. The influence of Erna3 and Frieda5 operations is lower and never exceeds 20%;
- overstress areas correspond to the Louise TB zone and the zone ahead of the Irma-1250 face;
- in the intermediate zone (where the part of the Frieda5-1250 panel on which mining operations are taking place is located, and the part of the bottom level affected during the accident); the vertical stress in these zones is relieved;
- furthermore, the influence of mining operations in the Frieda5-1250 panel is limited to zones close to the part of the panel from which coal has been extracted, and in particular it appears weak in the part of the level affected by the accident.

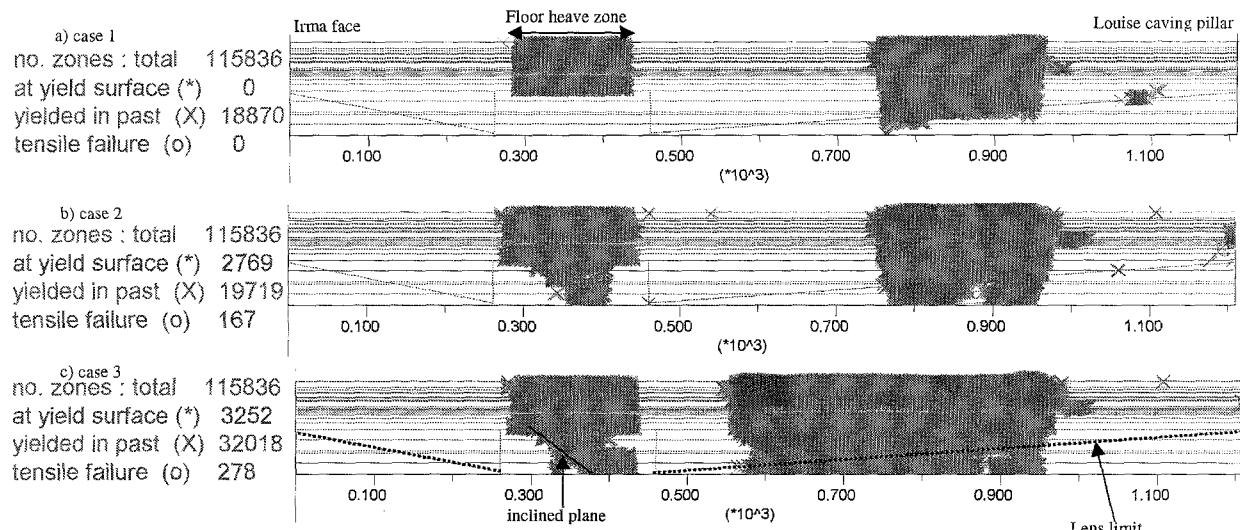
Fig. 6: Overview: distribution of plasticity

The mechanism studied would appear to be capable of reproducing total deconsolidation of the bed under some conditions (figure 6):

- the vertical stress relief in the accident zone must be less than or equal to 4 MPa;
- the North-South horizontal stresses must be high (higher than 60 MPa and therefore higher than the measurements made in situ);
- East-West horizontal stresses, and particularly shear stresses, are design parameters that are less sensitive than the previous two;
- the compression strength ( $R_c$ ) of the sandstone bed had to be halved so that the second sandstone bench could be fractured.

Case 1: 200 m advance

Case 2: 200 m advance, effect of the axial horizontal stress

Case 3: 400 m advance, effect of stress gradients

The results of this model determined operating and environmental conditions to reproduce the rockburst. These conditions are illustrated in figure 4 and are summarized below:

- 1) a bottom case with a variable thickness sandstone bed (between 0 m and 20 m) and a 125 m wide zone in which vertical stresses were relieved;
- 2) a bottom case mode with N-S horizontal stresses increased by 25 %;
- 3) same mode as above (case 2) but with the Frieda 5 face advanced by 400 m, which is close to the accident configuration.

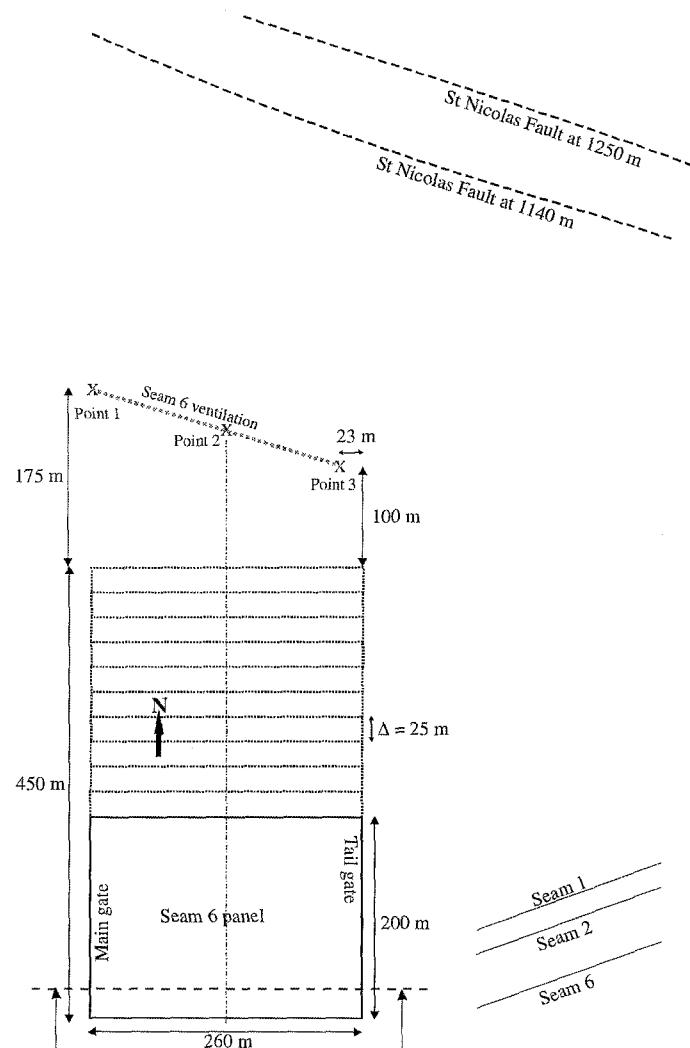
Fig. 5: Different steps in modeling the advance on the Seam 6 panel.

The advance of the panel between 200 m and 470 m (maximum length) is simulated in 12 steps (figure 5). The model includes all mined panels of the Reumaux Mines (HBL).

The results were analyzed considering the variation of the state of stress with the advance of panel 1140-1250 (figure 5). The comments can be made on this model:

- operation of the Seam 6 panel will have an influence ahead of the faces of the Seam 1 and 2 panels starting from an advance of 325 m. This is a very small modification compared with the initial state before operation of the panel;

- starting from 400 m, the influence becomes more significant. It corresponds to an increase in the normal stress (zones close to the roof track increase by 2 MPa, the 28 MPa contours move by 110 m ahead of the face on the bottom level) and an increase in the east-west horizontal stress at the face of the 1st panel in Seam 1 (increase of 2 MPa);

- in the ventilation zone, the greatest increase concerns the east-west horizontal stress, which is 15% of the initial value. The normal stress only increases by 5%. No modification is observed for the north-south horizontal stress;

- the front ends of Seams 1, 2 and 6 do not intersect until the advance reaches 450 m (the planned length).

The panel is surrounded by four faults including the St. Nicolas fault which is by far the most important fault, but is furthest from the panel (figure 5).

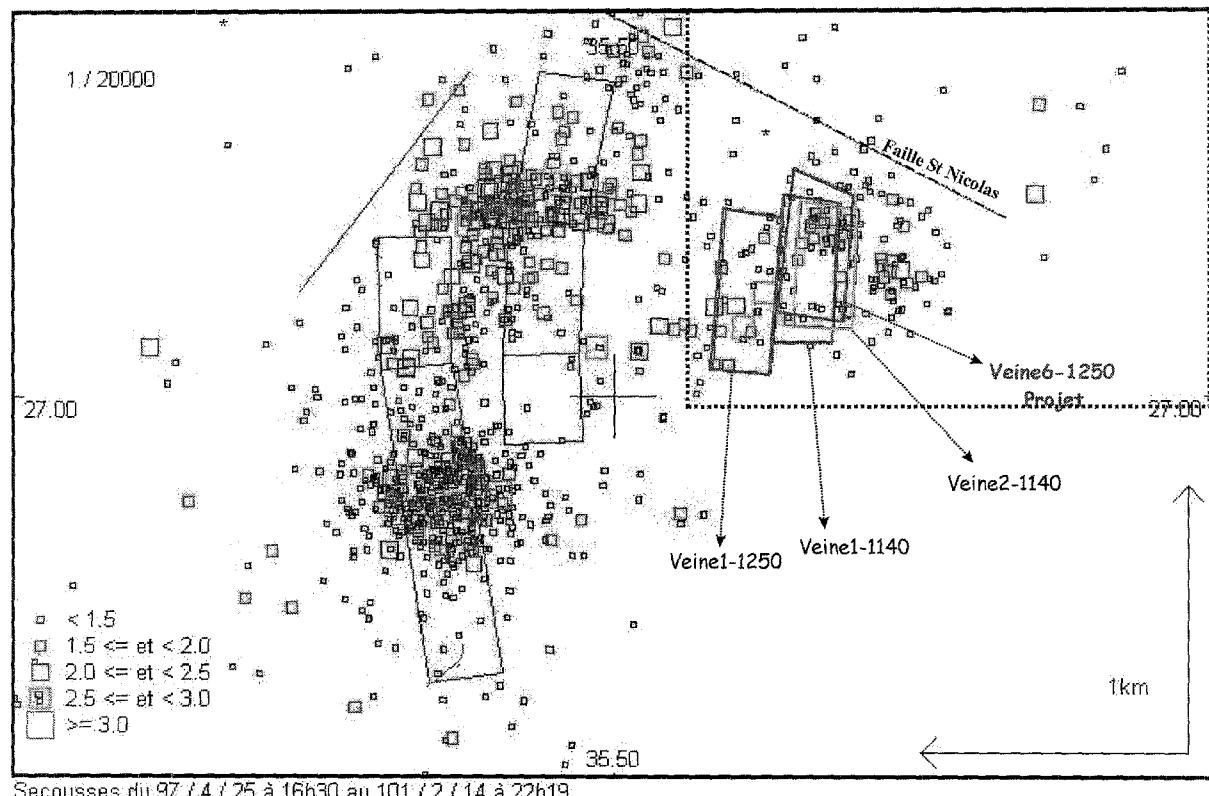
Fig. 6: Seismic activity of Seams 1 sector (1140, 1250 panels), Seam 2 (1140 panel), 1995-2001 period

Seismic activity related to all mining operations carried out between 1995-2001 is represented by the spatial distribution of focuses of events recorded in the HBL regional listening network. Based on the distribution of focuses in the zone limited to Seams 1 (panels 1140, 1250) and 2 (panel 1250), it is quite obvious that seismic activity is much lower (209 events) than was observed in the West sector (Irma, Erna and Frieda, 1500 events). A distinction is made between three activity distributions (figure 6):

1. minor rock bursts, most with a magnitude of less than 1.5, related to ruptures close to the St Nicolas fault;
2. a cluster of focuses located at about a hundred meters to the East of the panels in the preferred NS direction. A single rock burst with a magnitude of more than 2 is identified;

- throughout the entire sector, only two rock bursts with a magnitude equal to 2.7 have been recorded and were located in the Seam 1-1250 panel.

- the seismic activity related to mining operations on Seams 1 and 2 is particularly weak compared with the activity in the sector of the Frieda5 cut;
- only 7 of the 209 recorded events have a magnitude of more than 2.0.
- identified mechanisms at the focus associate these events with shear type failures.

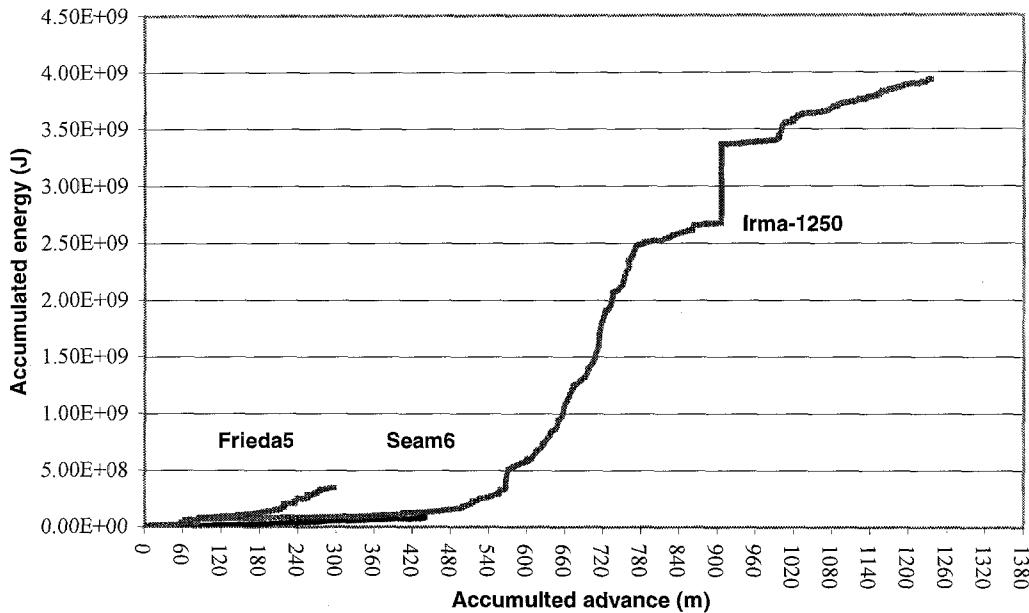
Fig. 7: Curves of energy dissipated during mining operations of the Frieda5, Seam6 and Irma-1250 cuts

Figure 7 shows curves of the energy dissipated during operation of the Irma-1250, Frieda5-1250 and Seam 6 fronts as a function of the advance. For the three fronts, the energy is calculated starting from the seismoacoustic data. Irma-1250 was exploited over the longest length (1300 m), and advance of the Frieda5 and Seam 6 fronts was 300 m and 444 m. respectively. Thus, a comparison can be made between the three energy variation curves for an advance of up to 444 meters. An analysis of the three curves shown in figure 6 shows that the energy level released by the Frieda5 front is the highest and that the relief speed increases quickly after 180 m advance. For the Irma-1250 front, the dissipated energy is low until 420 m and then increases gradually. Note that the energy released by the front in Seam 6 is the lowest throughout the entire mining operation period.

The seismic activity related to mining operations of Seam 6 was very weak ; The regional monitoring network did not record any rock bursts that could be assigned to the front. The number of events recorded in the seismoacoustic activity is greater, but the events are low energy.
