## Back-analysis of the rockburst in Frieda 5 and design program for panel in seam 6 (HBL-France)

Vincent Renaud, Lynda Driad, Marwan Al Heib, J.-F. Noirel

Vincent Renaud, Lynda Driad, Marwan Al Heib, J.-F. Noirel. Back-analysis of the rockburst in Frieda 5 and design program for panel in seam 6 (HBL-France). ROCKBURSTS International Symposium 2002, Nov 2002, Ustron, Poland. pp.313-326. ineris-00972385

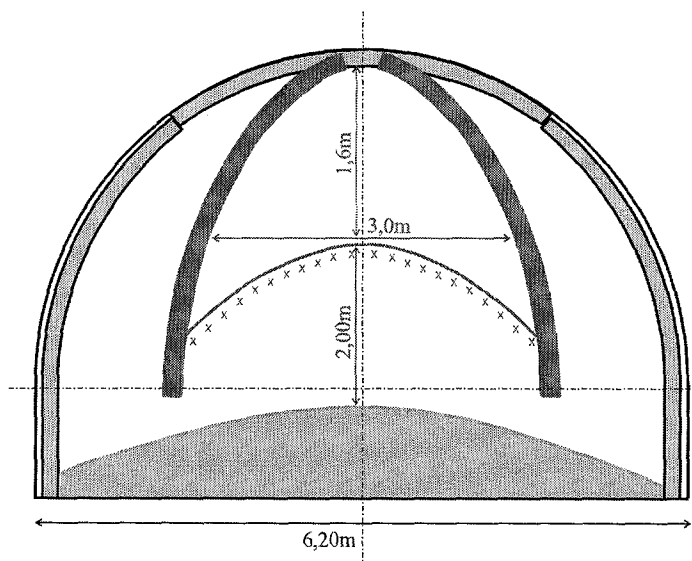
On June 21 2001, a fatal rock burst affected the main gate of the Frieda 5-1250 panel in the Merlebach Mine (HBL). The rock burst was extremely violent (magnitude 3.6). The heave exceeded 2 m (figures 1 and 2, HBL note number 384/01-JPA/ND [3]). The damaged zone was 250 m long and was located at between 100 m and 350 m in front of the face (between the sides).

Fig. 1: Diagram showing bottom level blow off.

The seismic focus of the 21/06/01 event is located on the Frieda5 main gate 100 m in front of the face (figure 1). The location in depth shows that the depth of the focus of this event is about 1400 m (estimated depth below the surface, figure 2) at 200 m from the Frieda5 cutting face.

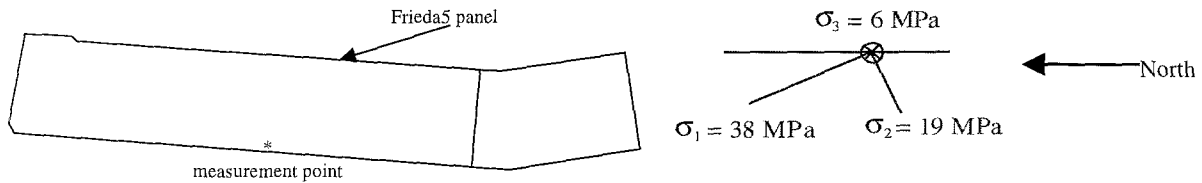
Stress measurements show that horizontal stresses are very high and the vertical stress is less than the weight of the ground (figure 4).

Fig. 4: Stress diagram in accident zone
