Multi-scale analysis of water alteration on the rockslope stability framework

Sandra Dochez, Farid Laouafa, Christian Franck, Sylvine Guedon, François Martineau, et al.. Multi-scale analysis of water alteration on the rockslope stability framework. 16. French-Polish Colloquium of Soil and Rock Mechanics, Jul 2013, Montpellier, France. pp.NC, 2013. <ineris-00973700>

MULTI-SCALE ANALYSIS OF WATER ALTERATION ON THE ROCKSLOPE STABILITY FRAMEWORK

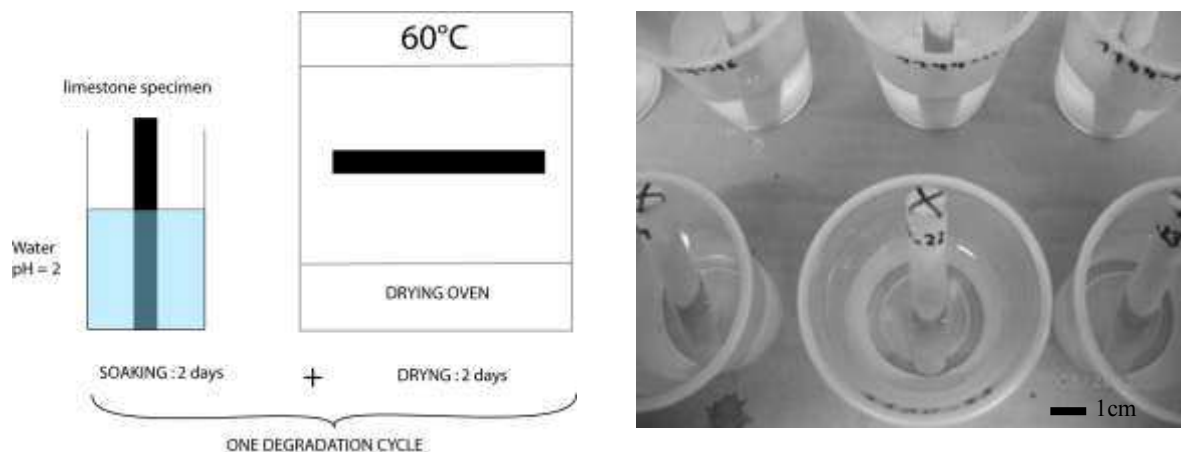
Figure 1: Schematic representation of the two steps of the experiment “alteration in quasi- static regime” which is composed of one cycle of weathering (left). Picture of the first phase of the experiment quasi-static regime limestone samples sticks are soaking in the acidic water (right).

This first experiment consists in leaving limestone's samples at rest in a fixed volume of acidic water (Figure 1). The evolution of weight of each samples during cycles of alteration are measured at different times. A cycle is composed of two steps. During the first step all samples are soaked 2 days in a sulfuric acid solution

at pH 2 then during the second step samples are dried at 60°C for 2 days (Figure 1). The acidic solution is renewed. Thanks to that change, the alteration is more effective by repetitions of these cycles, *in fine*, the samples degradation is increased.

The rock samples are cylindrical (diameter: 12 mm, high 100 mm) (Figure 1). A number of 24 sticks samples are used for each type of limestone. We used four types of limestone: Pierre de Caen (Caen Stone), Pierre de Lens (Lens Stone), Larrys and Comblanchien whose differ by their porosity. Limestones' porosity extend to a range from one to several tens percent. Caen Stone and Lens Stone have a high porosity respectively 20% and 17%, whereas the two others have a low one respectively 7% and 1%.

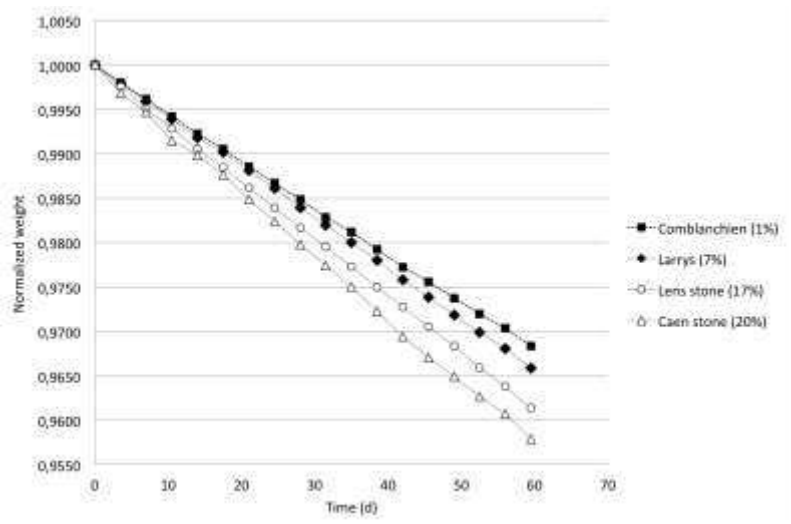
Figure 2: Evolution of sample weight during the experiment Alteration in static regime.

The evolution of each sample weight is measured during the dissolution process. A decrease of weight is measured for each type of limestone. Figure 2 represents normalized weight (weight (t)/weight (0)) versus time of degradation. We noticed linearity with time of the loss of weight for all the type of limestone (Figure 2). This indicates there is a constant rate of dissolution for limestone. In this figure below, we can observe that whatever the giving porosity the rate of decreasing weight is quite constant. However we can observe the higher the porosity, the higher the rate. This difference of rate means that the dissolution process also affects the pores of the matrix although the pore pressure is very small. Moreover the dissolution process has a higher influence on the more porous sample (Caen stone).

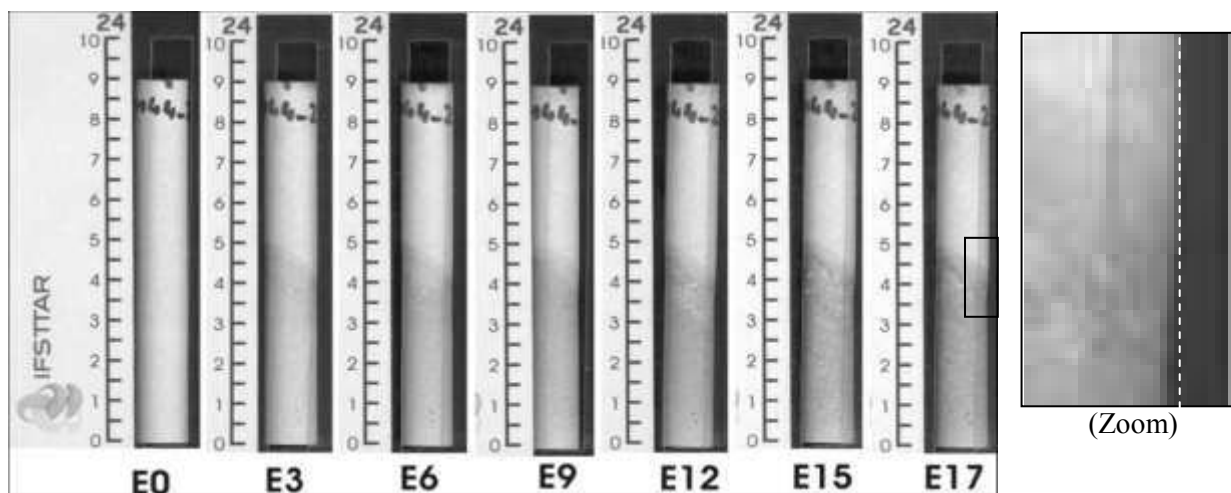
Figure 3: Pictures of Caen Stone samples: Initial state (E0), after 10 days (E3), 20 days (E6), 30 days (E9), 40 days (E12), 50 days (E15) and 60 days (E17).

At the fluid-air interface recognized by the different of coloring, a recession of the surface is observed for each sample of each limestone (Figure 3, Figure 4). This recession suggests a loss of material. The high degradation in this part of the sample is also attributed to the influence of the CO₂ in ambient air. Actually, CO₂ is considered as an important acidifying component of water. The interface is the place where the exchange between ambient air and the water near the surface is the most important, makes it a zone where degradation is improved.

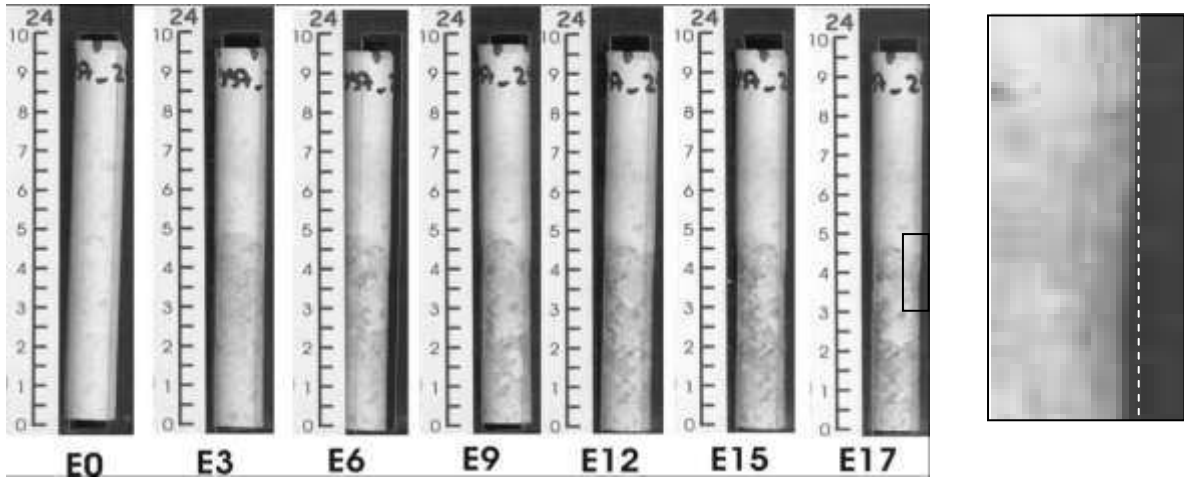
Figure 4: Pictures of Larrys samples during alteration: Initial state (E0), after 10 days (E3), 20 days (E6), 30 days (E9), 40 days (E12), 50 days (E15) and 60 days (E17).

We observe the same high degradation near the interface, for all types of limestone. This information suggests an influence of CO₂ whatever the porosity.

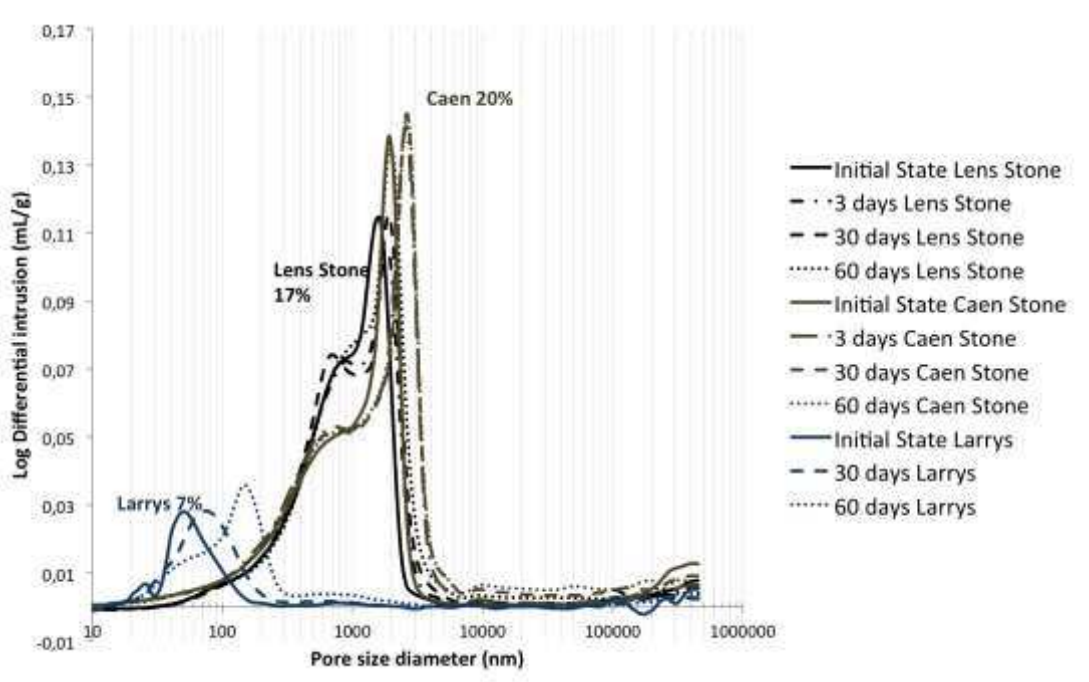
Figure 5: Volume of mercury intrusion versus pore size diameter for samples of Lens Stone, Caen Stone and Larrys and for several state of weathering

In order to evaluate the different states of alteration of the porous matrix evolution inside the sample, mercury intrusion porosimetry (MIP) measures have been done. This method is commonly used to evaluate the total porosity and the pore size distribution of different materials. MIP results are expressed as the total mercury volume intruded (log differential intrusion) in a sample versus pore size (mean diameter pore). Measures were carried out after several cycles of degradation. The Figure 5 shows the volume of mercury intrusion versus the pore diameter. We represent on the graph three of the four limestone used for the study (Larrys (7%) Lens Stone (17%) and Caen Stone (20%)). First of all we can observe the mean pore diameter increases with the limestone's porosity. Then for each type of limestone there is an increase of the mean pore diameter between the initial state and 3 days of alteration. The alteration increase pore volume. Low porosity sample have little mean pore diameter whereas high porosity have their mean diameter higher. Matrix of Lens Stone and Caen Stone samples are modified after the first cycle. Indeed an aperture of the mean diameter pore is measured after the first cycle but the mean diameter doesn't increase for the other cycles. Nevertheless on Lens Stone, the volume of mercury increases between 30 days and 60 days of alteration. This reveals an increase of pores with same size. Larrys' samples show an increase of the mean diameter pore all along the state of degradation (Figure 5).

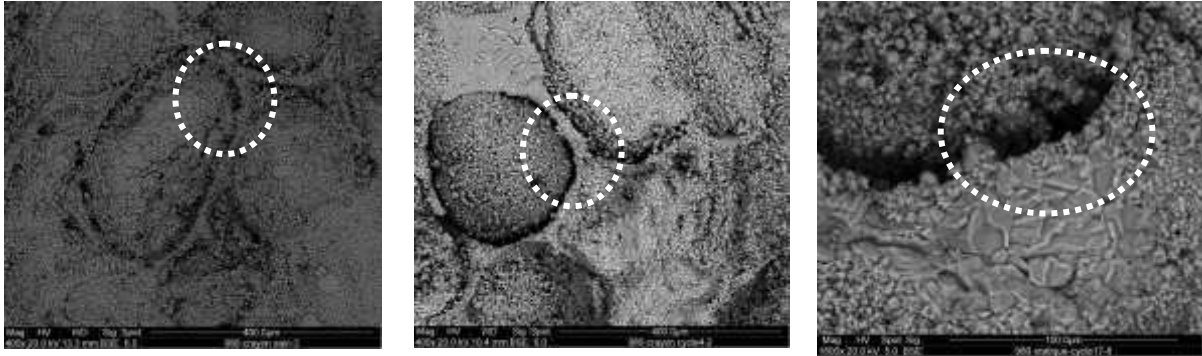
Figure 6: ESEM pictures from sample of Lens Stone at initial state (left) after 10 days (middle) and after 60 days (right). The dash line circles emphasize the gap between oolites; this gap was created during the alteration.

We observe sample of limestone named Lens Stone at micro-scale with an environmental scanning electron microscope (ESEM) (Figure 6). These three pictures show three states of limestone degradation's at different time, the first represents non-altered sample, the second at 10 days of alteration and the last one after 60 days of alteration. The limestone observed is Lens Stone, it is composed of ooids which are spherical grains composed of concentric layers. We observe along the period of alteration a digging around the ooids, which indicates dissolution of calcite. This kind of feature shows the non-homogeneous fact of dissolution either at space scale.

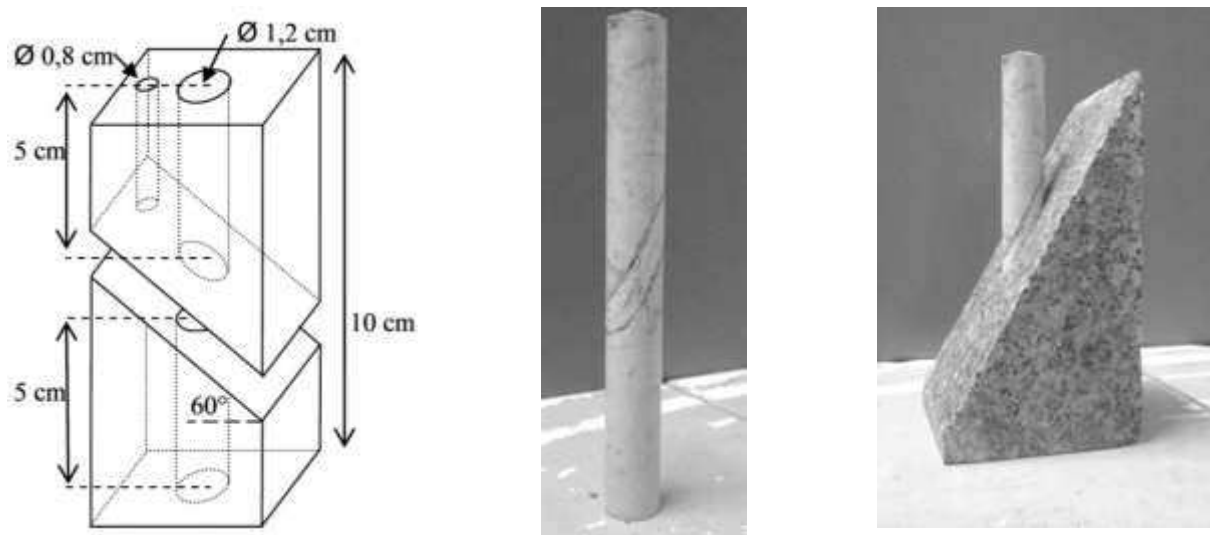
Figure 7: Shape of the granite base with dimension (left) the sample of limestone (middle) are inserted into the granite for the test (right) (after Druon)

In order to the observation and measurement of chemical degradation an evaluation of the mechanical response of the sample submitted to a shear loading is performed. The measurements are made with a uniaxial cell in order to evaluate the influence of alteration on the mechanical properties of limestone samples. We used cylindrical samples (Figure 7) as samples in the alteration in quasi-static experiment. Each sample is positioned in a shaped granite base (Figure 7) and put in the uniaxial cell (Figure 8).

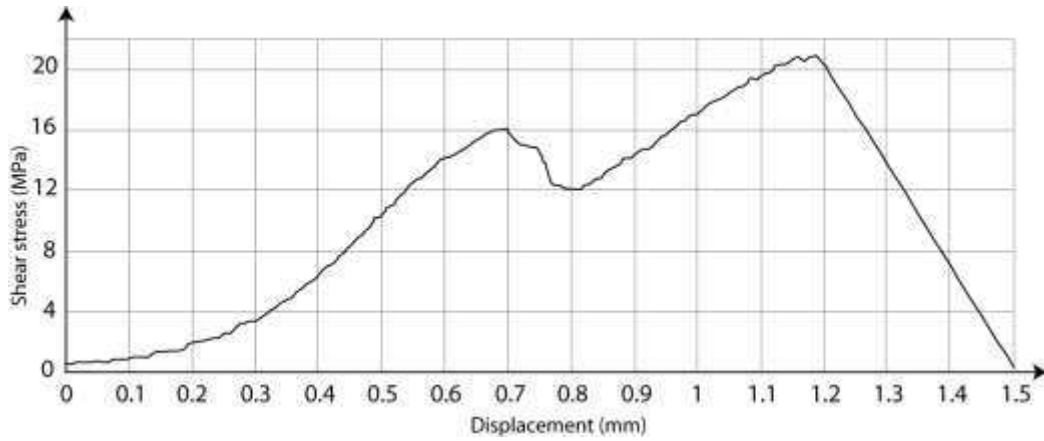
Figure 10: Evolution of shear stress versus tangential displacement for the limestone Larrys (modified from Druon, 2011).

The following experiment focused on non-altered Larrys (7%) sample. The Figure 10 shows the evolution of shear stress versus tangential displacement. The curve shows an increase to a peak at 16 MPa and a decrease to 12 MPa. This first part of the curve with the little peak, indicate a first micro-crack in the limestone sample. After that the shear stress rises to a maximum at 21 MPa and after the shear stress collapse. This part of the curve represents the rupture of the sample.

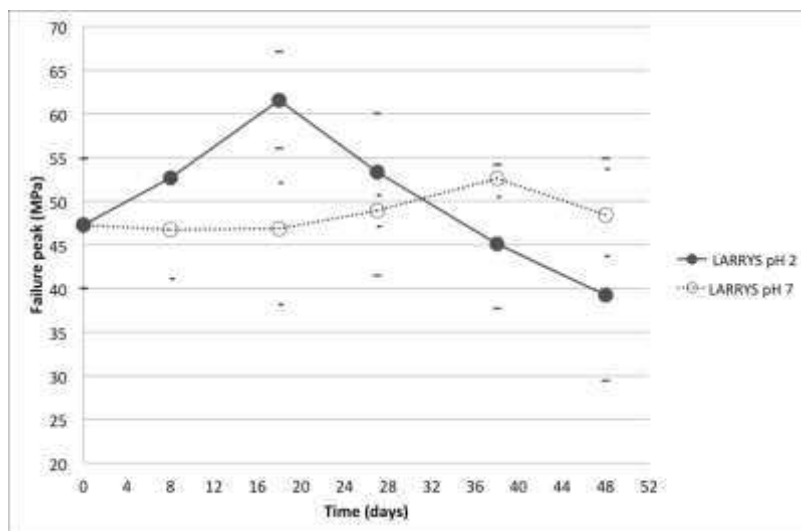
Figure 11: Evolution of the mean failure peak after period of alteration for Larrys limestones. A comparison between different water, acid (pH 2) and neutral (pH7). Dashes (above and below) represent respectively the standard deviations max and min. The small dashes for pH2, and the large dashes for pH 7(modified from Druon, 2011).

The Figure 11 shows the evolution of Larrys' samples mean failure peak during alteration period for two different pH degree of water (pH 2 and neutral water pH (7)). Which is surprising in that two curves show an increase of mean peak rupture to a maximum and a decrease. They have the same shape except the maximum for the acid water (pH 2) appears before that for rain water (pH 7). The difference between the curves points out the acceleration process of dissolution. The comparison between two different pH degrees of water shows how much the influence of pH water is relevant during the alteration process. Furthermore the slope before the peak for the pH 2 curve is stronger than the slope for pH 7.

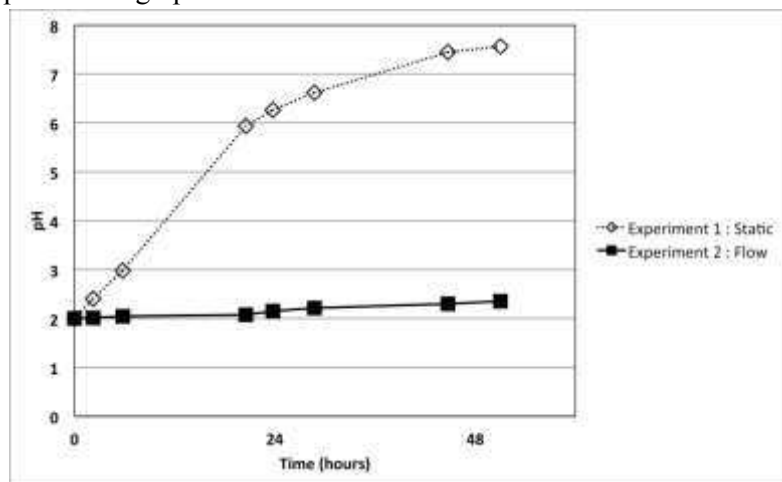
Figure 13: Representation of the evolution of pH as a function of time, the dotted curve with open symbols shows the evolution in the case of an alteration in static water regime: limestones (CaCO_3) are soaking in an acidic solution (H_2O ; H_2SO_4). The solid curve and filled symbols shows the evolution in the case of an acidic solution flows along the limestone.

Figure 13 depicts the time evolution of water pH during two different experiments. A continuous flow on the limestone surface; maintains pH stability around 2 whereas limestone's sample immersion in an acidic solution buffers it at pH 7. This graph shows how time-contact between rock and solution is relevant.

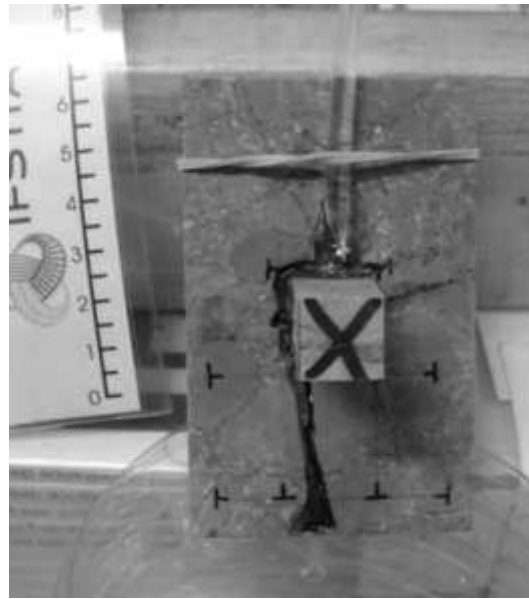
Figure 14: Picture of Montagnole limestone (CaCO_3) sample surface degradation by acidic solution (H_2O ; H_2SO_4)

The experiment is performed in an open system, which means the sample in contact with ambient air. The interaction with the CO_2 of the ambient air increases the phenomenon. The flow of water causes a material dissolution and deconstruction (Figure 14). Fine particles are observed in the water of the recovery basin as

observed by Kupper [13]. The picture shows also an asymmetric flow of the solution. Indeed we observed during the period of runoff that water followed different paths. It is obvious that water prefers the easier path to dissolve crystals less competent than the rest of the rock sample.

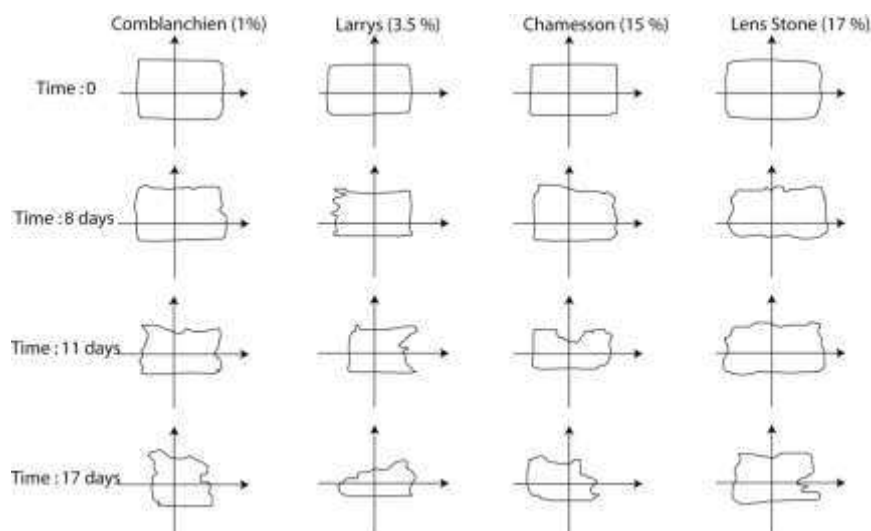
Figure 15: Comparison between the different states of alteration for each limestone of their rock bridges' perimeter measured with laser.

Each type of limestone received 12 liters of acid solution flowed for a period of 17 days. After 8, 11 and 17 days, a geometric analysis by laser is performed. Many profiles were done in order to show the influence of the alteration surface and to establish the decreasing of the rock bridge perimeter. This decreasing of the perimeter is observed during the water flowing for all samples (Figure 15). In addition we noticed an intact part of the rock bridge below. The recession of the rock-bridge perimeter may imply a decrease of the mechanical resistance of the rock bridge.

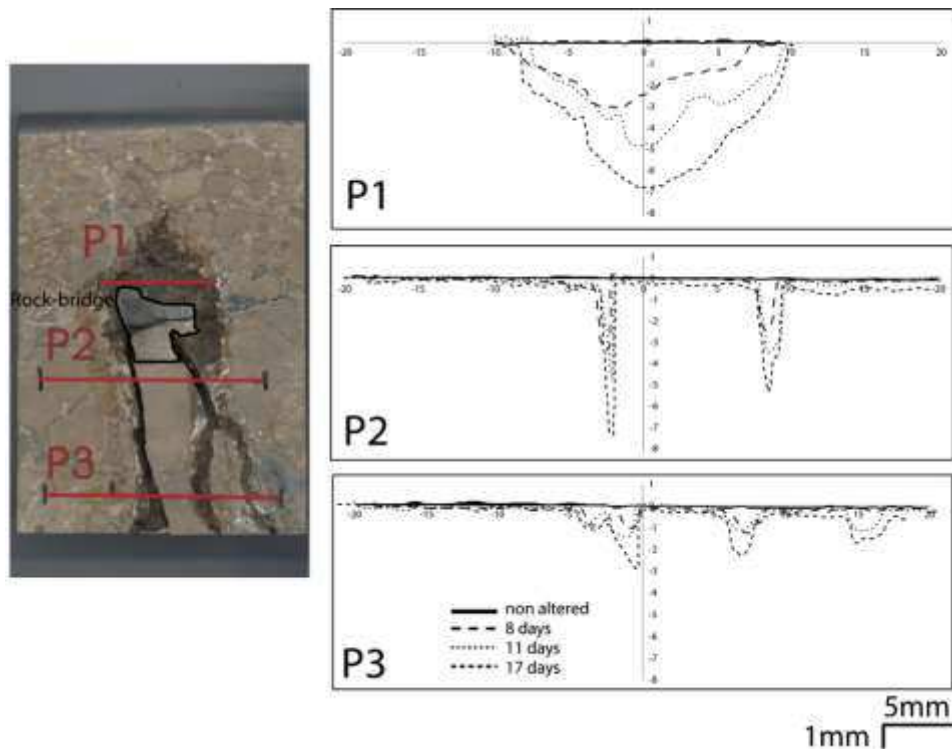
Figure 16: Montagnole sample after acidic water runoff, line P1, P2, P3 represent the place we take the profile by laser (left). These graphs represent the 3 profiles done by laser, the different curves show the evolution of the “topography” of the sample surface during alteration period (right)

We performed other laser profiles (Figure 16). Profile P1 was taken above the bridge then profile P2 just under the bridge, and the third P3 was measured on the below far from the bridge (Figure 16). These profiles were made at initial state, after 8 days of runoff, 11 days and at final state (17 days). Profile P1 is made near the place where the drop fell. It shows a digging which increases significantly over time. Profiles under the

bridge show two diggings (P2) then three (P3). These paths followed small fractures. These ones indicates preferential path of water circulation (P2 and P3).

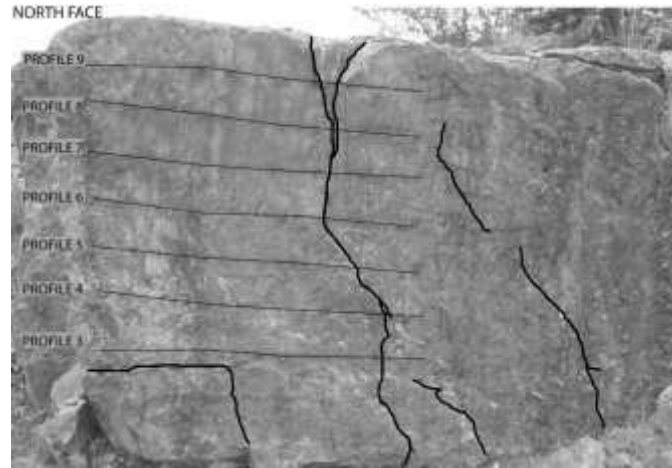
Figure 18: Depict of the North Face of the block in Chambéry (73). The black lines reveal the different discontinuities observed. The black horizontal lines identified each radar profile, profile 3 to 9 from the bottom to the top.

GPR data were acquired using high frequency (1600 MHz) to estimate the presence of rock bridges (continuity in the rock mass). This high frequency is adapted to detect interfaces such as rock-air-rock in two meters thick. The air tends to disperse the signal, so we can deduce the rock bridge's presence or not. In this paper, GPR measurements consisted in profiles acquired from the block (Figure 18), in order to make a grid of the block and identify the presence of rock bridges.

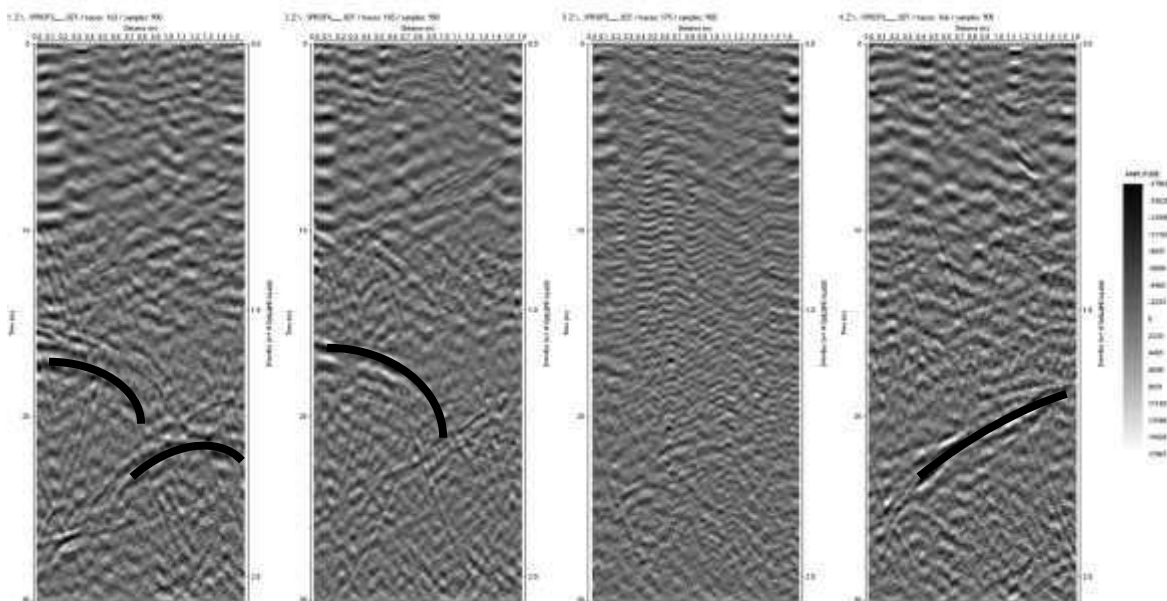
Figure 19: Radar gram acquired after profiles from the block, profile 3 to 6, the black lines represented the weirdness observed and used for the 3D representation.

The first observation in situ reveals many discontinuities; the major ones represented in black on Figure 17 are those where we suppose there are rock bridges to maintain the stability of the rock mass. The white ones appear to be just on the surface but they are important for the surface degradation. The GPR reveals the possibility to identify the surface discontinuity (Figure 19). As a matter of fact radar-gram present some weirdness, these ones are the proofs of different environment as air or rock mass. These are analyzed and after a treatment, a 3D view of the discontinuity surface could be made as Figure 20 shows.

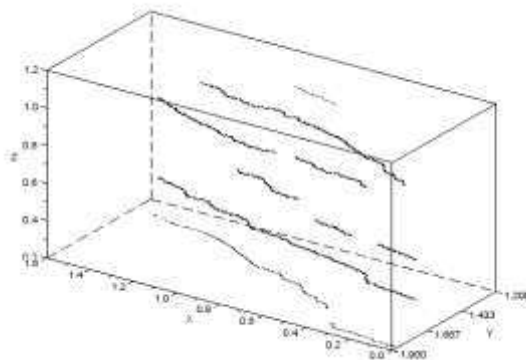
Figure 20: 3D view of the surface discontinuity after analyze and treatment of the data.

Figure 20 show horizontal dots, which represented the separation between rocks and void i.e. the discontinuity inside the block.
