Multi-scale analysis of water alteration on the rockslope stability framework

Sandra Dochez, Farid Laouafa, Christian Franck, Sylvine Guedon, François Martineau, et al.. Multi-scale analysis of water alteration on the rockslope stability framework. 16. French-Polish Colloquium of Soil and Rock Mechanics, Jul 2013, Montpellier, France. pp.NC, 2013. <ineris-00973700>

MULTI-SCALE ANALYSIS OF WATER ALTERATION ON THE ROCKSLOPE STABILITY FRAMEWORK

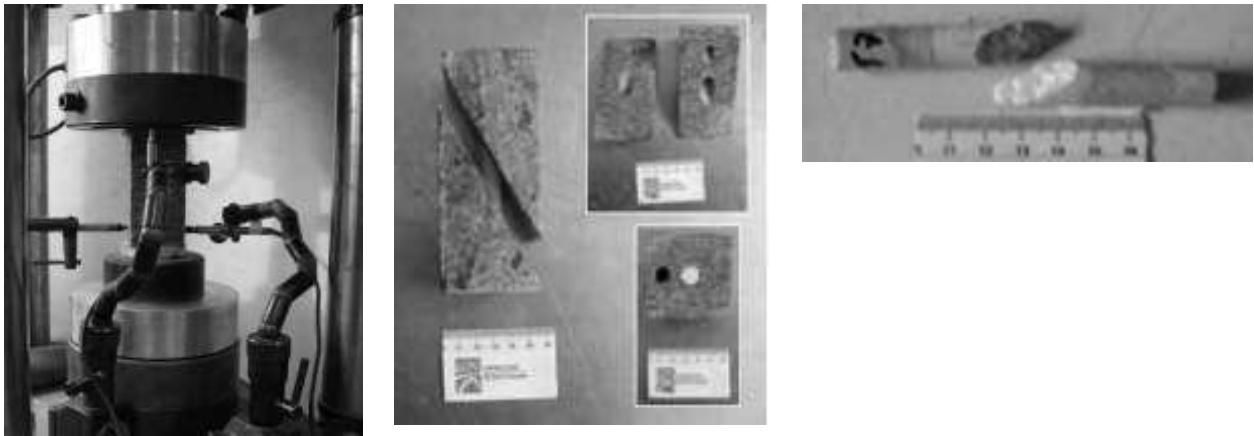
Figure 8: Picture of the uniaxial cell used for the experiment “alteration quasi-static” (left). Sample in the granite base (middle) and the broken sample after the test (right) (after Druon).

The loading (kinematically controlled) applied for the shear on the weathered sample is measured and it is called: *mechanical strength*. Each sample is sheared in order to compare them in function of their porosity in one case and their weathering degree in another case.
