MULTI-SCALE ANALYSIS OF WATER ALTERATION ON THE ROCKSLOPE STABILITY FRAMEWORK

ABSTRACT: Water is an important weathering factor on rock discontinuities and in rock mass mechanical behavior. The increase of rainfall in frequency or in intensity highlights some problems on the rock slope stability analysis. The aim of this paper is the multi scale analysis of the chemical impact of water on rock (surface roughness and matrix). In this study we show how water induces degradation and thus may decrease the stability of the discontinuous rock mass. Water is known to have significant erosion and dissolution effects on rock surface or rock matrix. The chemical features of water such as temperature, pH or salinity make it a “good” candidate to rock degradation. This study has two main components. The first one is the study of water-solid chemical mechanisms and the other is the analysis of the mechanical response of the discontinuity modified by the water alteration. The stability of the rock mass is naturally a function of the type and the space distribution of discontinuities. The study aims also to evaluate the effect of water flow on the rock slope stability and it is performed at two

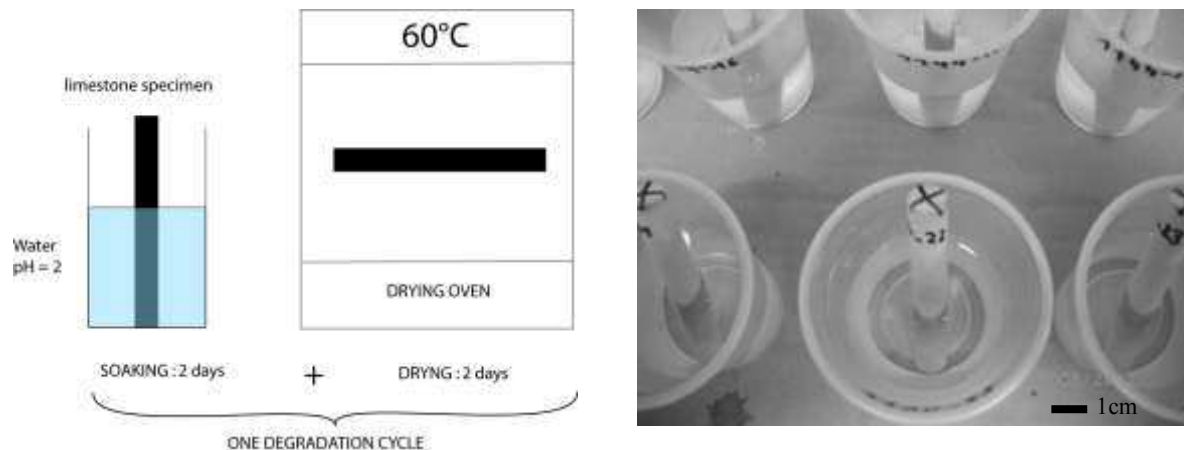
Figure 1: Schematic representation of the two steps of the experiment “alteration in quasi- static regime” which is composed of one cycle of weathering (left). Picture of the first phase of the experiment quasi-static regime limestone samples sticks are soaking in the acidic water (right).

This first experiment consists in leaving limestone's samples at rest in a fixed volume of acidic water (Figure 1). The evolution of weight of each samples during cycles of alteration are measured at different times. A cycle is composed of two steps. During the first step all samples are soaked 2 days in a sulfuric acid solution

at pH 2 then during the second step samples are dried at 60°C for 2 days (Figure 1). The acidic solution is renewed. Thanks to that change, the alteration is more effective by repetitions of these cycles, *in fine*, the samples degradation is increased.

The rock samples are cylindrical (diameter: 12 mm, high 100 mm) (Figure 1). A number of 24 sticks samples are used for each type of limestone. We used four types of limestone: Pierre de Caen (Caen Stone), Pierre de Lens (Lens Stone), Larrys and Comblanchien whose differ by their porosity. Limestones' porosity extend to a range from one to several tens percent. Caen Stone and Lens Stone have a high porosity respectively 20% and 17%, whereas the two others have a low one respectively 7% and 1%.

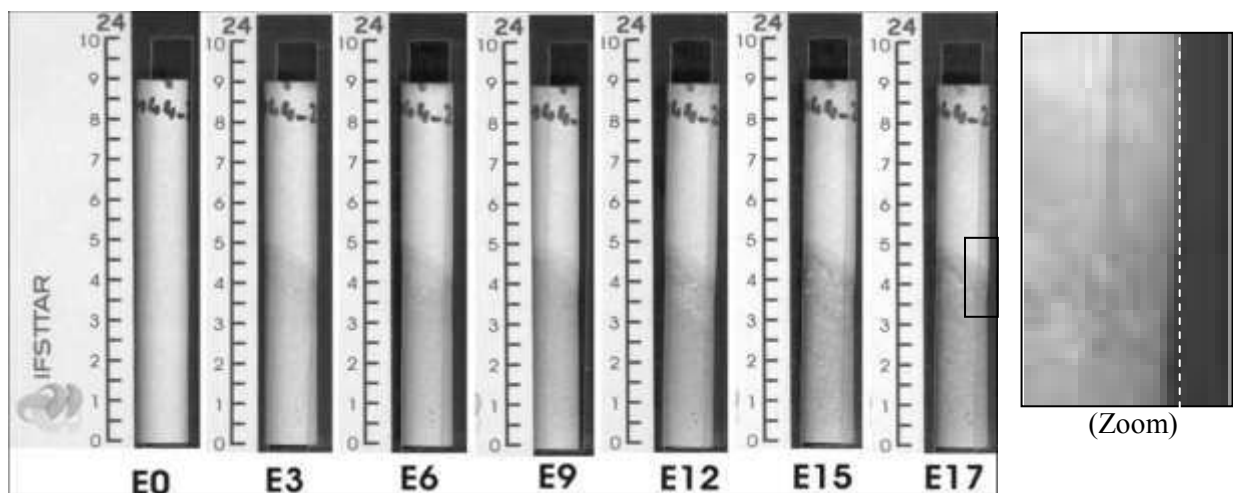
Figure 3: Pictures of Caen Stone samples: Initial state (E0), after 10 days (E3), 20 days (E6), 30 days (E9), 40 days (E12), 50 days (E15) and 60 days (E17).

At the fluid-air interface recognized by the different of coloring, a recession of the surface is observed for each sample of each limestone (Figure 3, Figure 4). This recession suggests a loss of material. The high degradation in this part of the sample is also attributed to the influence of the CO₂ in ambient air. Actually, CO₂ is considered as an important acidifying component of water. The interface is the place where the exchange between ambient air and the water near the surface is the most important, makes it a zone where degradation is improved.

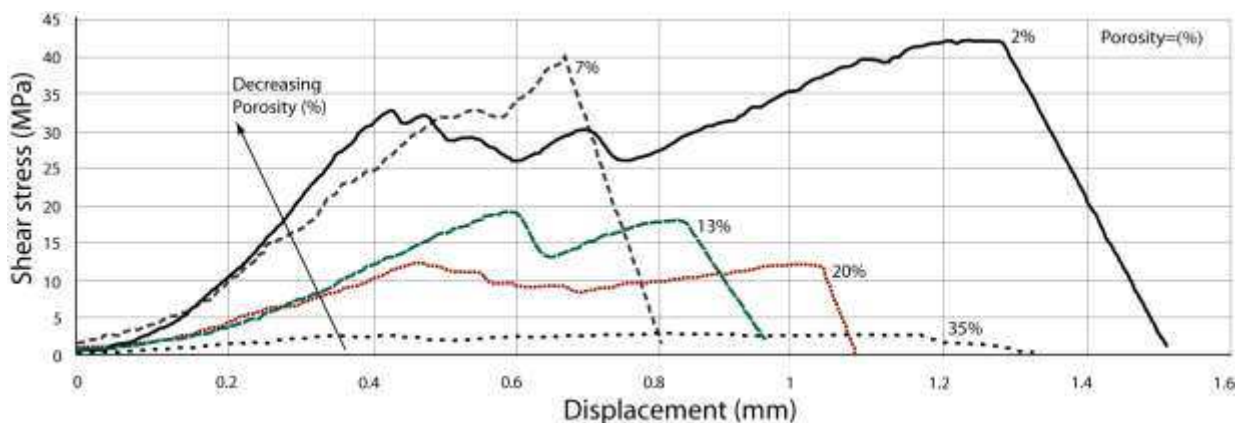
Figure 9: Shear stress versus tangential displacement for different limestone’s porosity (modified from Druon, 2011 [10]).

Shear strength measurements are performed on different non-altered limestone samples on a range of porosity 2% from 35 % (Figure 9). The different curves show an increase in the shear stress versus tangential displacement until a peak is reached and then a decrease followed by an increase to a maximum and then failed. The first stress drop is associated to micro-cracks of the sample and the final stress drop is related to the failure of the sample. All limestone samples seem to have the same behavior.

We noticed the smaller the porosity the stronger slope, this implies that the slope of curves is hardening with the decreasing porosity. It suggests porosity affects the mechanical response of samples.

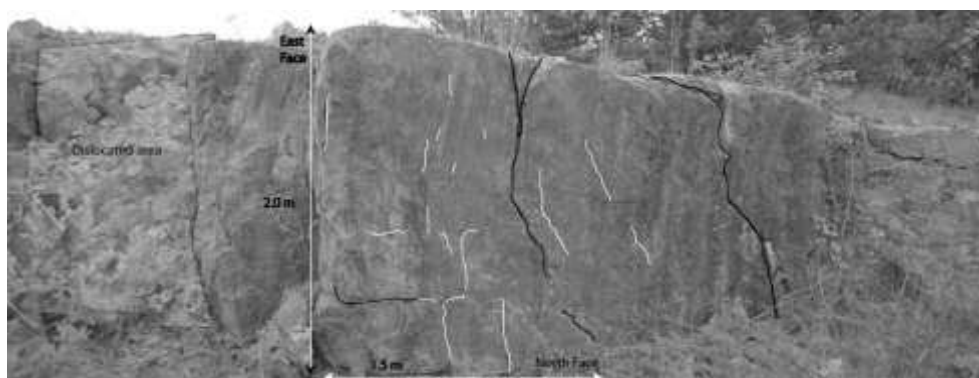
Figure 17: View of the rock mass, it presents a dislocated area on the left, and major discontinuities are in black and superficial are in white.

The site is located in Montagnole near Chambéry (73) in France. The block is a triangle shaped dihedral with fractures and it is apparently ready to fall (Figure 17). This work aims to evaluate the potential of Ground Penetrating Radar (GPR) measurements to find and estimate the quantity of rock bridges into a block with a discontinuity.

The first observation in situ reveals many discontinuities; the major ones represented in black on Figure 17 are those where we suppose there are rock bridges to maintain the stability of the rock mass. The white ones appear to be just on the surface but they are important for the surface degradation. The GPR reveals the possibility to identify the surface discontinuity (Figure 19). As a matter of fact radar-gram present some weirdness, these ones are the proofs of different environment as air or rock mass. These are analyzed and after a treatment, a 3D view of the discontinuity surface could be made as Figure 20 shows.
