MULTI-SCALE ANALYSIS OF WATER ALTERATION ON THE ROCKSLOPE STABILITY FRAMEWORK

ABSTRACT: Water is an important weathering factor on rock discontinuities and in rock mass mechanical behavior. The increase of rainfall in frequency or in intensity highlights some problems on the rock slope stability analysis. The aim of this paper is the multi scale analysis of the chemical impact of water on rock (surface roughness and matrix). In this study we show how water induces degradation and thus may decrease the stability of the discontinuous rock mass. Water is known to have significant erosion and dissolution effects on rock surface or rock matrix. The chemical features of water such as temperature, pH or salinity make it a “good” candidate to rock degradation. This study has two main components. The first one is the study of water-solid chemical mechanisms and the other is the analysis of the mechanical response of the discontinuity modified by the water alteration. The stability of the rock mass is naturally a function of the type and the space distribution of discontinuities. The study aims also to evaluate the effect of water flow on the rock slope stability and it is performed at two

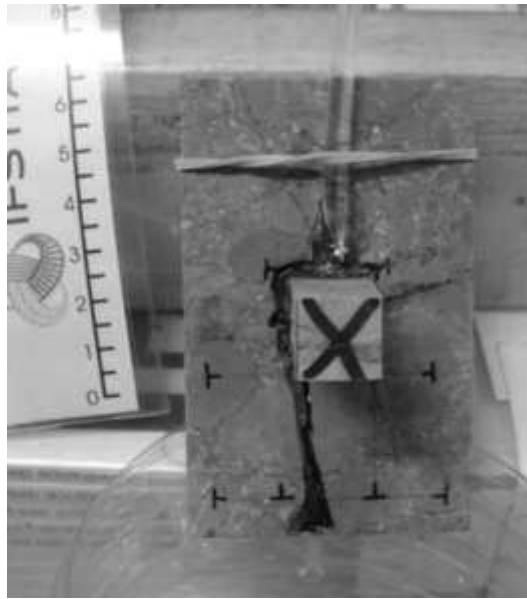
Figure 14: Picture of Montagnole limestone (CaCO_3) sample surface degradation by acidic solution (H_2O ; H_2SO_4)

The experiment is performed in an open system, which means the sample in contact with ambient air. The interaction with the CO_2 of the ambient air increases the phenomenon. The flow of water causes a material dissolution and destructure (Figure 14). Fine particles are observed in the water of the recovery basin as

observed by Kupper [13]. The picture shows also an asymmetric flow of the solution. Indeed we observed during the period of runoff that water followed different paths. It is obvious that water prefers the easier path to dissolve crystals less competent than the rest of the rock sample.

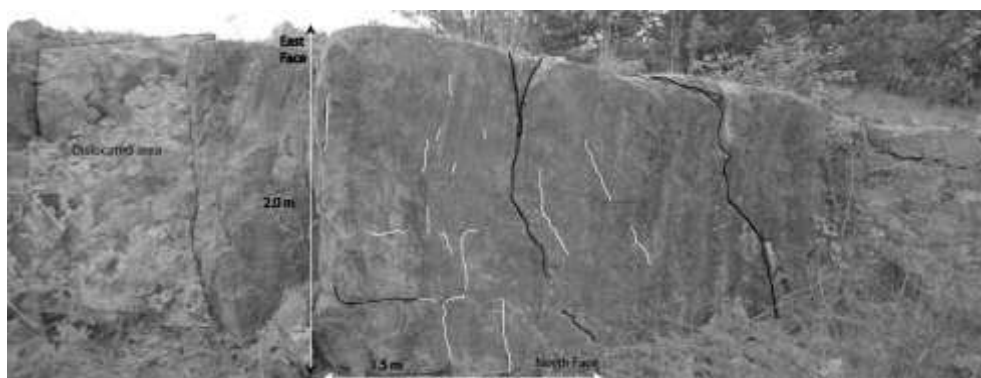
Figure 17: View of the rock mass, it presents a dislocated area on the left, and major discontinuities are in black and superficial are in white.

The site is located in Montagnole near Chambéry (73) in France. The block is a triangle shaped dihedral with fractures and it is apparently ready to fall (Figure 17). This work aims to evaluate the potential of Ground Penetrating Radar (GPR) measurements to find and estimate the quantity of rock bridges into a block with a discontinuity.

The first observation in situ reveals many discontinuities; the major ones represented in black on Figure 17 are those where we suppose there are rock bridges to maintain the stability of the rock mass. The white ones appear to be just on the surface but they are important for the surface degradation. The GPR reveals the possibility to identify the surface discontinuity (Figure 19). As a matter of fact radar-gram present some weirdness, these ones are the proofs of different environment as air or rock mass. These are analyzed and after a treatment, a 3D view of the discontinuity surface could be made as Figure 20 shows.
