Multi-scale analysis of water alteration on the rockslope stability framework

MULTI-SCALE ANALYSIS OF WATER ALTERATION ON THE ROCKSLOPE STABILITY FRAMEWORK

KEY WORDS: Water, chemical degradation, rock discontinuity, stability.

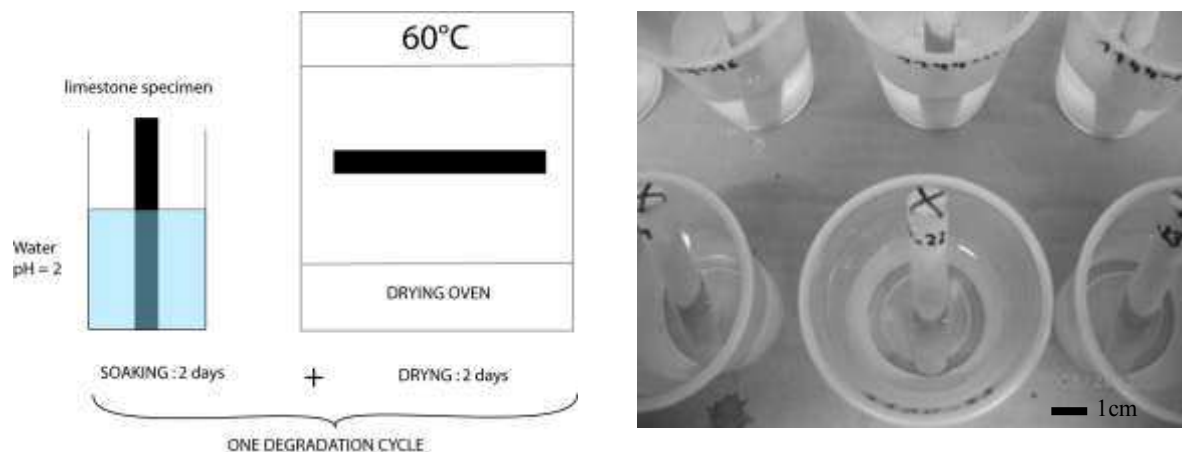
Figure 1: Schematic representation of the two steps of the experiment “alteration in quasi- static regime” which is composed of one cycle of weathering (left). Picture of the first phase of the experiment quasi-static regime limestone samples sticks are soaking in the acidic water (right).

This first experiment consists in leaving limestone's samples at rest in a fixed volume of acidic water (Figure 1). The evolution of weight of each samples during cycles of alteration are measured at different times. A cycle is composed of two steps. During the first step all samples are soaked 2 days in a sulfuric acid solution

at pH 2 then during the second step samples are dried at 60°C for 2 days (Figure 1). The acidic solution is renewed. Thanks to that change, the alteration is more effective by repetitions of these cycles, *in fine*, the samples degradation is increased.

The rock samples are cylindrical (diameter: 12 mm, high 100 mm) (Figure 1). A number of 24 sticks samples are used for each type of limestone. We used four types of limestone: Pierre de Caen (Caen Stone), Pierre de Lens (Lens Stone), Larrys and Comblanchien whose differ by their porosity. Limestones' porosity extend to a range from one to several tens percent. Caen Stone and Lens Stone have a high porosity respectively 20% and 17%, whereas the two others have a low one respectively 7% and 1%.

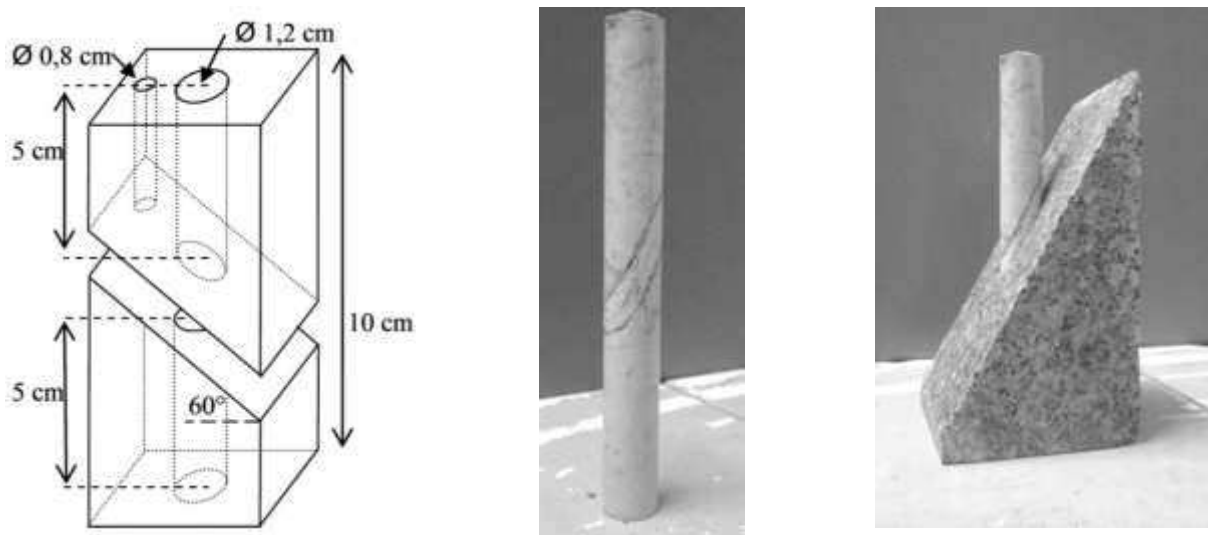
Figure 7: Shape of the granite base with dimension (left) the sample of limestone (middle) are inserted into the granite for the test (right) (after Druon)

In order to the observation and measurement of chemical degradation an evaluation of the mechanical response of the sample submitted to a shear loading is performed. The measurements are made with a uniaxial cell in order to evaluate the influence of alteration on the mechanical properties of limestone samples. We used cylindrical samples (Figure 7) as samples in the alteration in quasi-static experiment. Each sample is positioned in a shaped granite base (Figure 7) and put in the uniaxial cell (Figure 8).

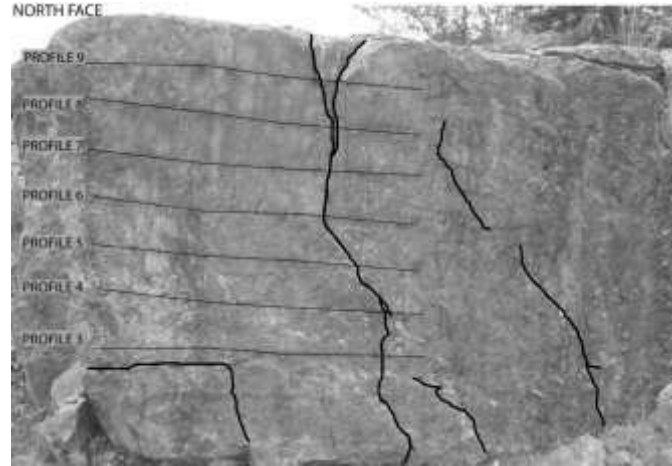
Figure 18: Depict of the North Face of the block in Chambéry (73). The black lines reveal the different discontinuities observed. The black horizontal lines identified each radar profile, profile 3 to 9 from the bottom to the top.

GPR data were acquired using high frequency (1600 MHz) to estimate the presence of rock bridges (continuity in the rock mass). This high frequency is adapted to detect interfaces such as rock-air-rock in two meters thick. The air tends to disperse the signal, so we can deduce the rock bridge's presence or not. In this paper, GPR measurements consisted in profiles acquired from the block (Figure 18), in order to make a grid of the block and identify the presence of rock bridges.
